Response Summary:

On November 7 and November 8, 2022, Spencer Harper (CESPN-ECE-W), Jeffrey Melby (CEERD-HNH), Dylan Robinson (CEERD-HNC) and Chad Bounds (CEERD-HNH) provided a walkover inspection of the north jetty at Noyo Harbor, CA in response to a DOTS request. SPN requested a site visit from the ERDC team to understand the conditions of Noyo Harbor, and the failing north jetty. A previous inspection of Noyo Harbor's jetties, conducted by SPN on August 11, 2021, described a large depression in the jetty crest on the leeward (north) side of the concrete monolith approximately 10 feet deep at some locations. The report also noted minor ejection of armor stone along the channel side of the jetty. Additionally, local stakeholders have observed large stone armoring displaced from the structure within the existing channel reducing the navigability of the channel. During the site visit, the DOTS response team observed waves breaking along the channel side of the concrete monolith creating a jet-like flow at low tide that could potentially dislodge poorly interlocked stones and move them into the channel. At high tide, the team observed waves breaking over the concrete monolith adjace

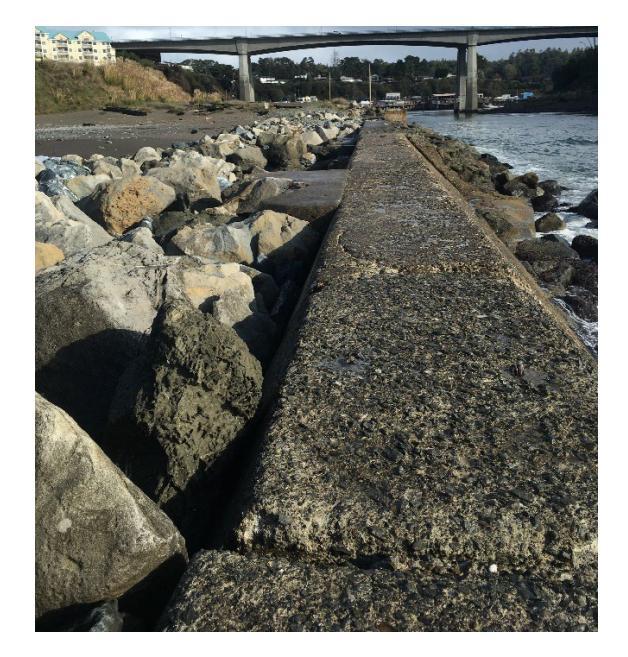
The structural condition of the north jetty was similar to that described during the August 11, 2021 inspection. A large depression existed on the jetty crest along the leeward side of the concrete monolith (Figure 3). During the 2019 north jetty repair, the contractors placed small stones along the jetty for construction equipment access. During the site visit, few of these stones remained on the structure, while similarly sized stones were found along the beach north of the structure. The stones along the beach were possibly from the jetty's construction access, and these stones may have been moved by wave forces from the crest of the structure to the beach. The crest depression may simply be the void left by movement of these stones.

Figure 3: Depression on leeward side of concrete monolith

Waves at high tide also propagated directly into the channel perpendicular to the jetty long axis. Again, as waves travelled along the southside of the north jetty, wave focusing from refraction, diffraction and breaking occurred towards the berm. Because the concrete monolith reflected the wave without dissipating large amounts of the wave energy, the wave height increased at the monolith (Figure 8). The wave was then observed to overtop the concrete monolith from south (channel side) to north. The location where the overtopping occurred during the site visit corresponded to the depression in the stone armoring on the north side of the jetty. Therefore, in larger wave conditions than observed at the site the morning of November 8, 2022, it could be hypothesized that greenwater overtopping occurs at this location along the jetty. This potentially destabilizes smaller stone on the north side of the jetty and is most likely causing the crest depression observed at the site.

Because the incident waves are highly oblique with respect to the jetty long axis and the waves breaking along the concrete monolith generate relatively high momentum, typical equations are not applicable. The DOTS response team suggests the use of a physical model, possibly in combination with numerical models.

There are no known armor stability formulae for this specific case. However, there are several modeling tools that could be applied to define a long-term solution to the berm mobility problem. Given the observed jet-like flow along the concrete berm and oblique angle of the overtopping waves, existing calculations, such as toe stability and stone armor sizing, cannot account for the observed conditions. In addition, it was not clear what hazards are causing the berm armor instability. The site is exposed to storm wave conditions over a wide range of water levels due to the large tide range. Waves strongly refract and diffract into Noyo Cove and so the wave height, period, direction and water level combination that results in the worst-case momentum along the berm is unknown. Therefore, the team suggests that a small-scale three-dimensional physical model study be conducted. The model would scale both fluid dynamics and armor stability. A range of different hazards (different incident wave conditions and various tidal levels) would be modeled, and the behavior of the jet-like flow along the concrete monolith and stone stability would be measured.

Additionally, a CFD model could be created using, for example, the Proteus Toolkit or CMS-Wave and CMS-Flow. This CFD model would have the capability to simulate the jet-like flow and determine the loads applied along the channel side of the jetty. The computed flow could be combined with simplified armor stability criterion like armor sliding and overturning to determine berm armor failure. The downsides of this method would be that the model requires validation, which would still support the need for a site-specific physical model study.

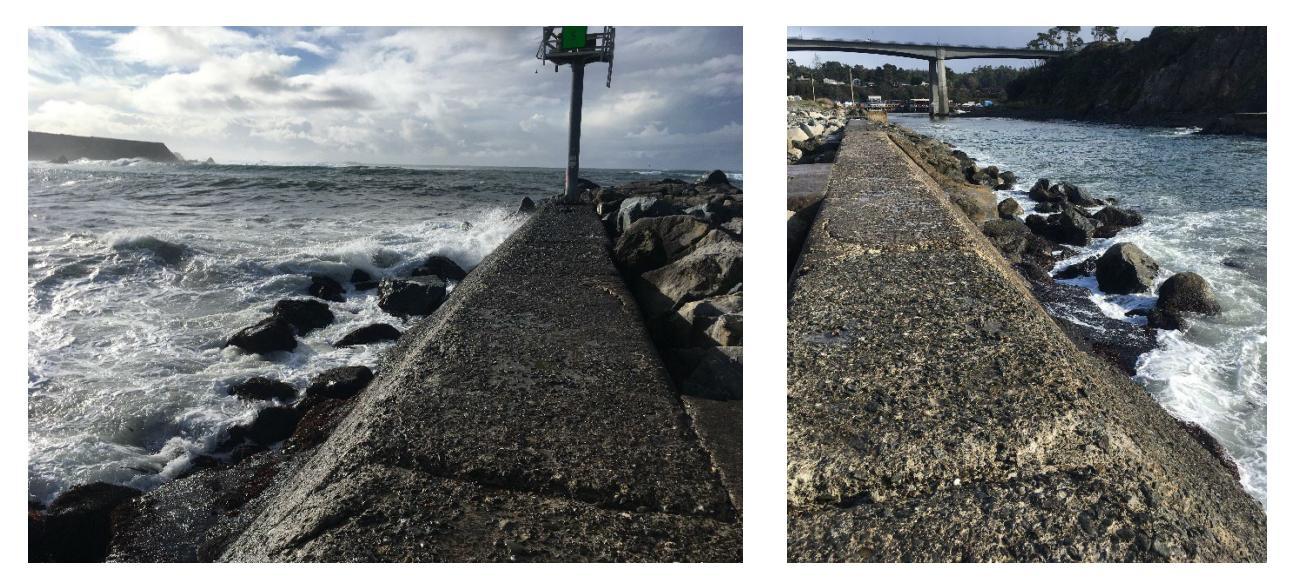
Although the head of the structure appeared to be in good condition, the stone armoring along the channel side of the concrete monolith appeared to be displaced from the concrete monolith and towards the center of the channel (Figure 4a and 4b). Some of the stones nearest the monolith appeared to be grouted to the structure, but there was limited evidence of interlocking with the concrete monolith keeping the remaining stone in place.

Figure 4a (left) stone armoring on channel side of concrete monolith looking seaward; Figure 4b (right) stone armoring looking landward

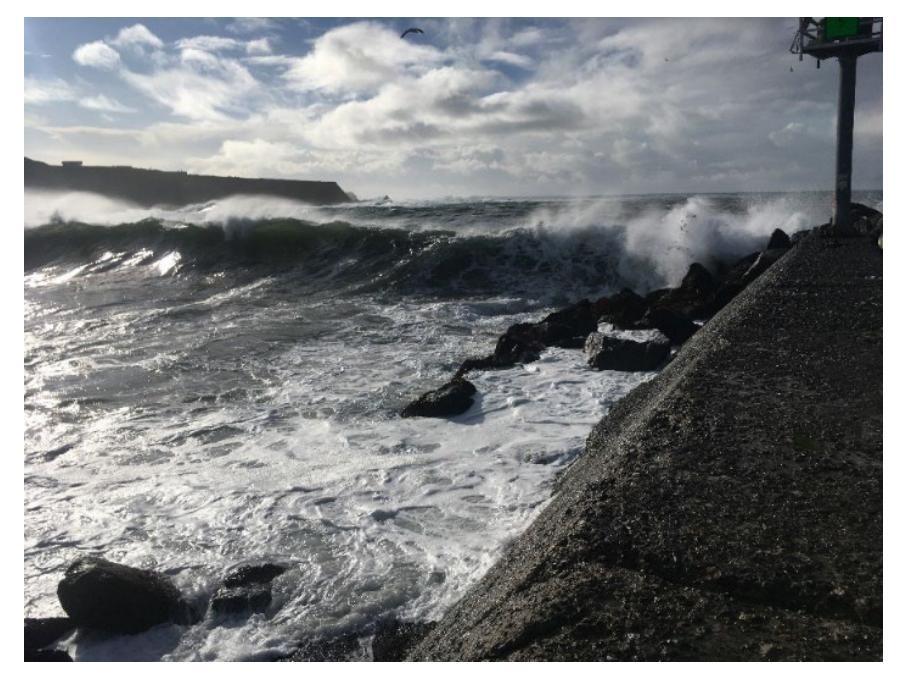
The site was first observed at low tide with the incident wave crests perpendicular to both the channel axis and the long axis of the north jetty (Figure 5). As waves passed the head of the structure, the wave refracted, diffracted and broke around the south side of the head. The wave continued to break and wrap around the head resulting in wave focusing into the seaward end of the berm that runs along the channel side of the concrete monolith (Figure 6). As the wave continued along the structure, this process continued in a mach stem, amplifying the broken wave momentum along the berm at the base of the concrete monolith. This created a jet-like flow that ran along the concrete monolith and could exert large forces on the remaining berm stone armoring (Figure 7). This could be what is pushing the berm stone off the structure and into the channel and may be the primary failure mode for this part of the structure. Also, there appeared to be large voids under the monolith. At low tide, water undercut the concrete monolith in some locations with a significant amount of water flowing out of the gap under the monolith after each wave passed. From the crest of the jetty, it could not be determined if stone armoring or grout from previous repairs still existed beneath the concrete monolith.

Figure 5: Wave entering channel at low tide (November 7, 2022)

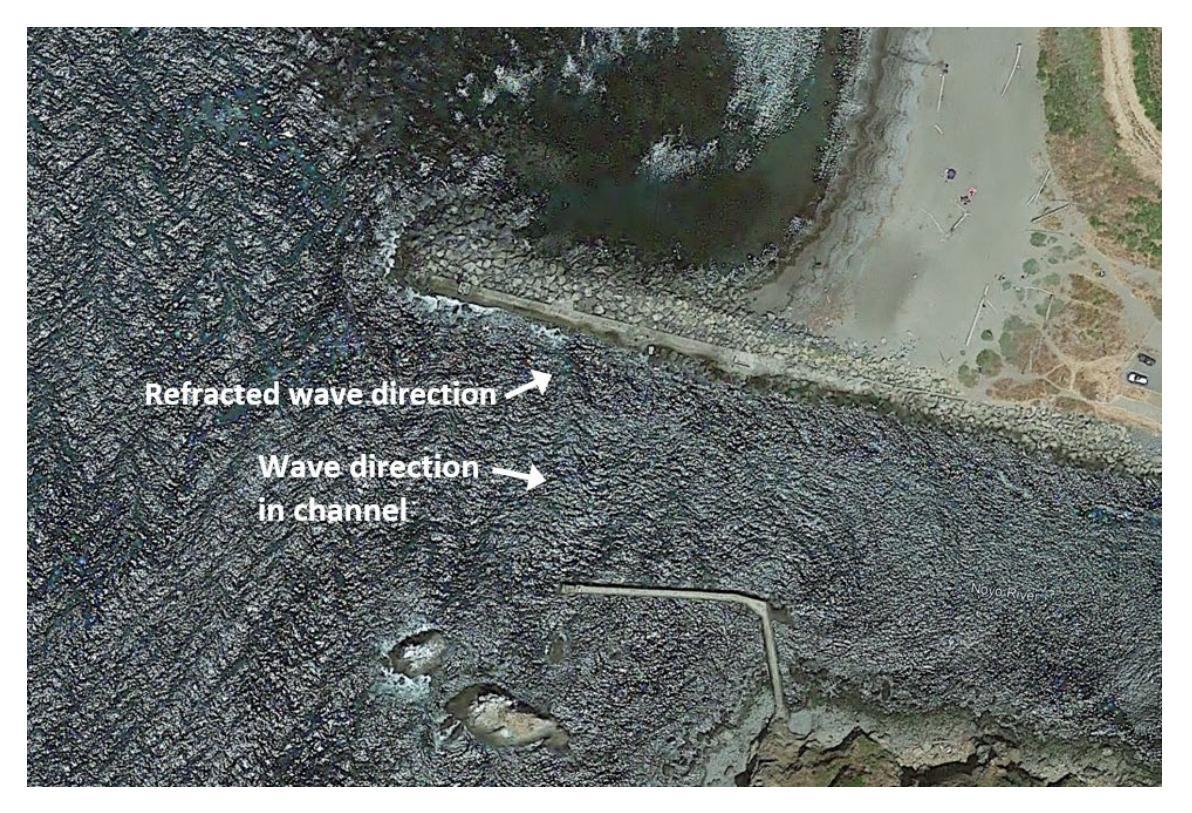
Figure 6: Refraction of wave along concrete monolith (Google Earth Pro, 2022)

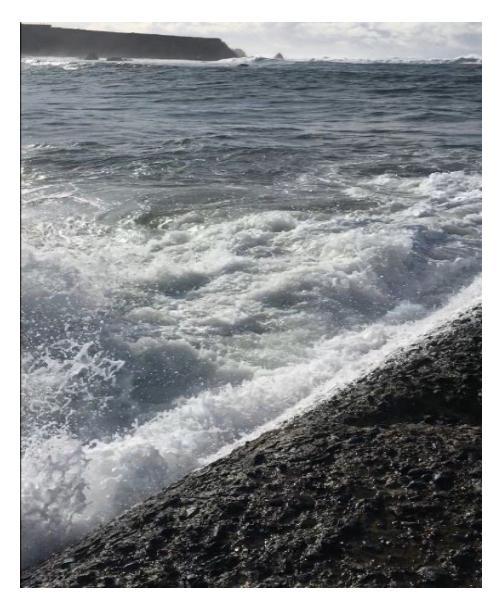
Figure 7: Jet-like flow along concrete berm at low tide (November 7, 2022)

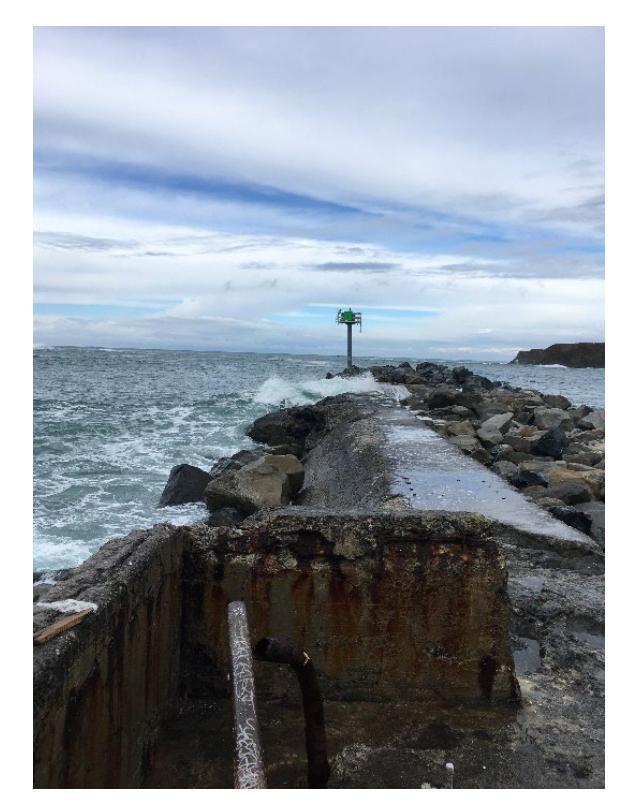
Figure 8: Wave overtopping concrete monolith at high tide (November 8, 2022)
