TECHNICAL REPORT D-77-23

HABITAT DEVELOPMENT FIELD INVESTIGATIONS
WINDMILL POINT MARSH DEVELOPMENT SITE
JAMES RIVER, VIRGINIA

APPENDIX B: PROPAGATION OF VASCULAR PLANTS

HABITAT DEVELOPMENT FIELD INVESTIGATIONS, WINDMILL POINT
MARSH DEVELOPMENT SITE, JAMES RIVER, VIRGINIA

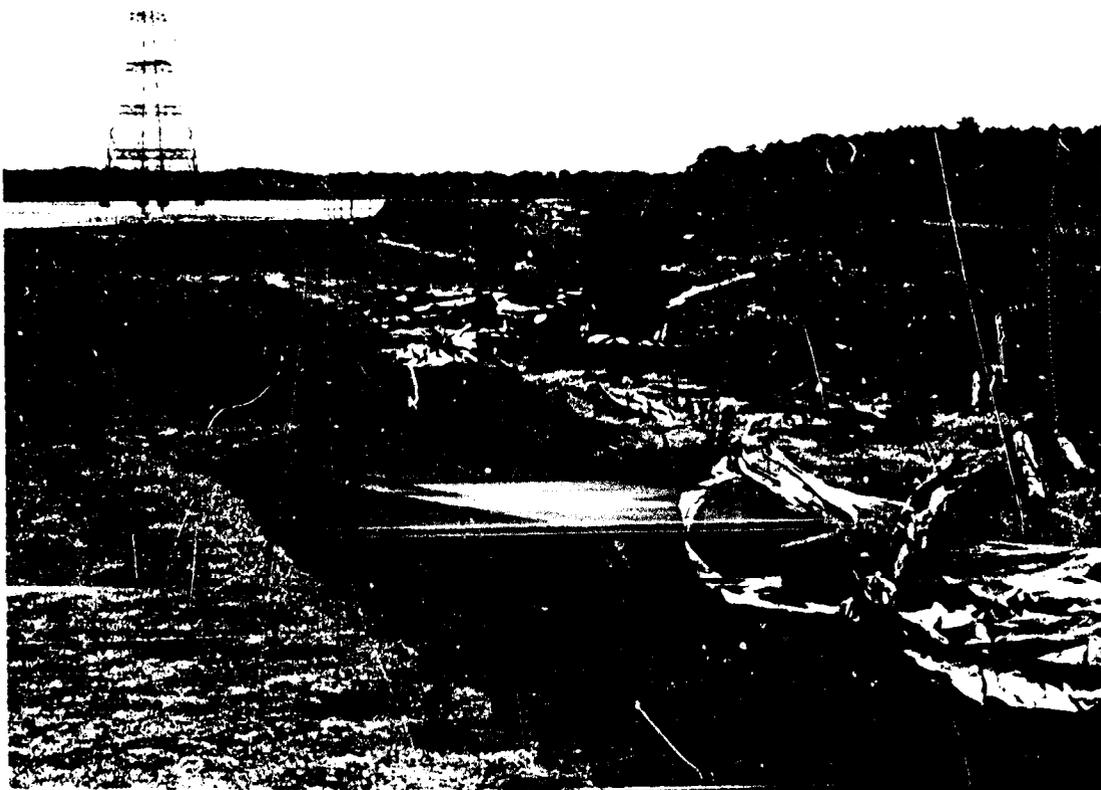
Figure 7. Looking east on 22 June 1975 along the north side of the dike at the steep berm and at the deposits of driftwood, debris, and plastic.

Upon arrival at the Site on 18 June 1975, extensive quantities of driftwood and debris were found deposited about the exposed north and west sides of the dike (see Fig. 7), plastic that had been sandbagged down over a constructed berm on the north and west sides of the dike was found both buried and strewn throughout the dike (see Fig. 8), and the constructed berm on the dike was found either severely eroding (see Fig. 9) or too steep (see Figs. 10-12) to plant directly. Prior to grading the dike to suitable slopes (10 or greater:1) for planting, the plastic, driftwood, and debris were collected, stockpiled, and burned (see Fig. 13).

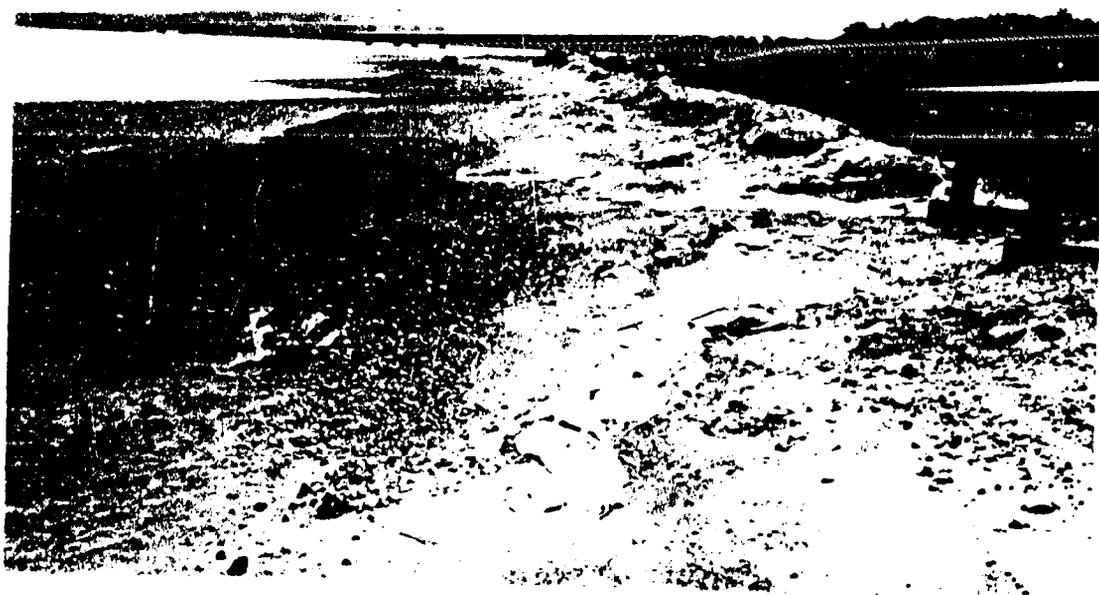
Figure 8. Plastic strewn about the dike on 22 June 1975.

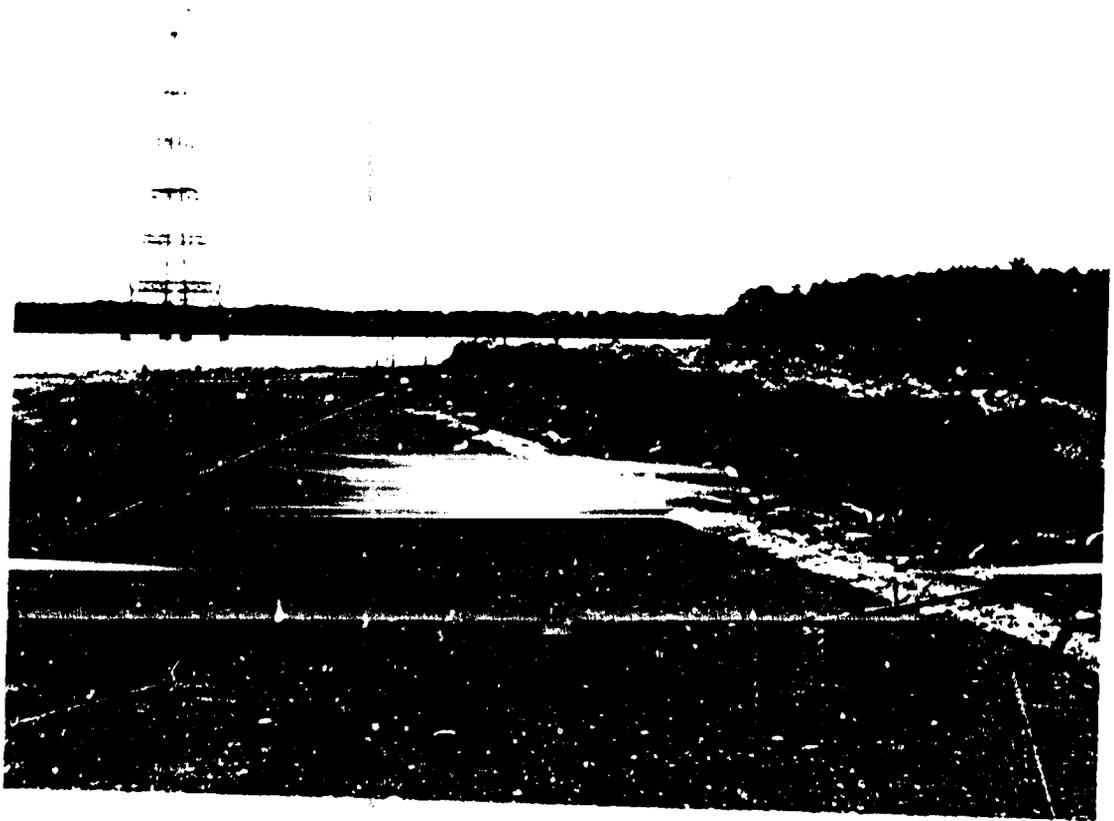
Figure 9. A steep, eroding section of the berm at the north-east end of the dike on 22 June 1975.

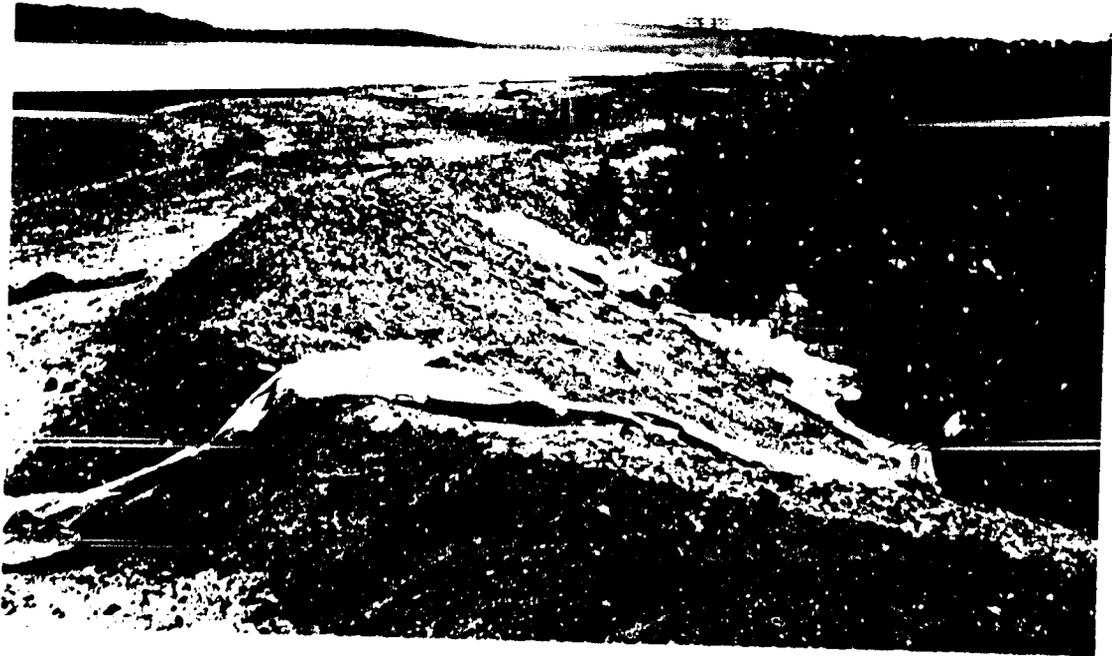
Figure 10. A section of steep berm at the northwest end of the dike on 22 June 1975.

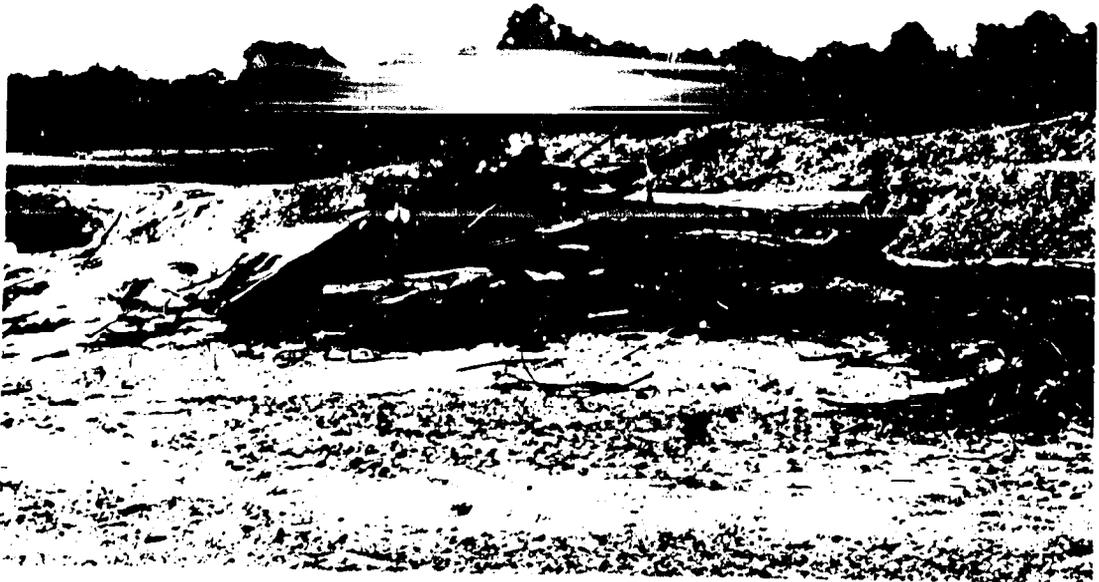
Figure 13. Burning of stockpiled plastic, driftwood, and debris at the Site.

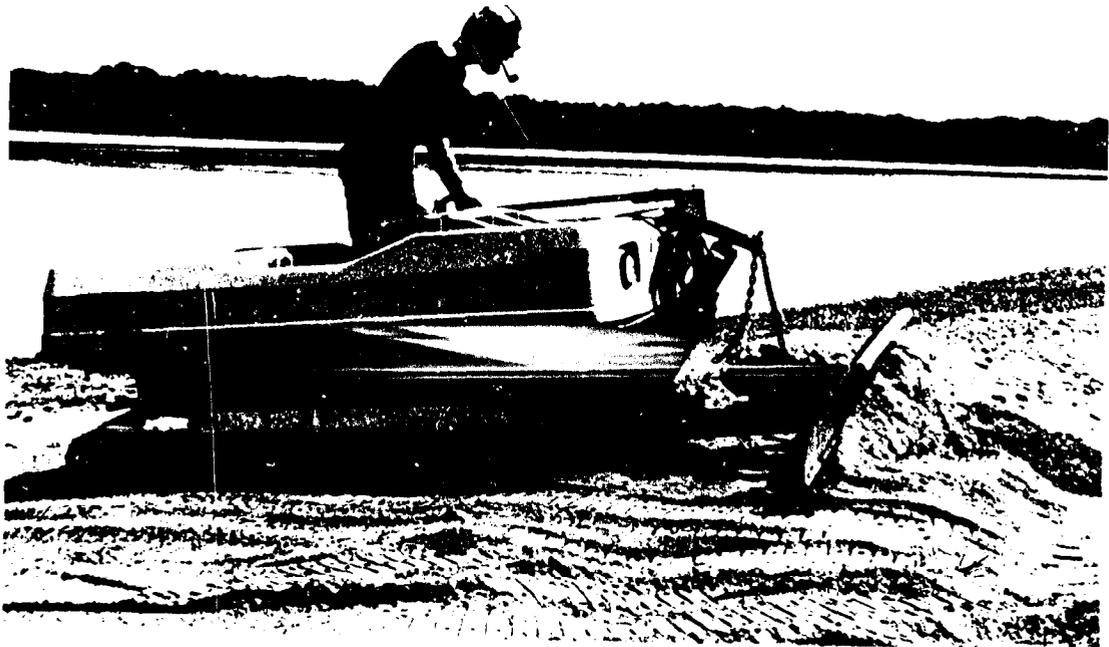
Figure 14. Grading operation using a low ground pressure vehicle.

a. Dike Grading. Grading of the dike was accomplished with a low ground pressure vehicle equipped with a hydraulic lift plow (see Figs. 14 and 15). Although the grading process was slow, it eliminated the risk of having a

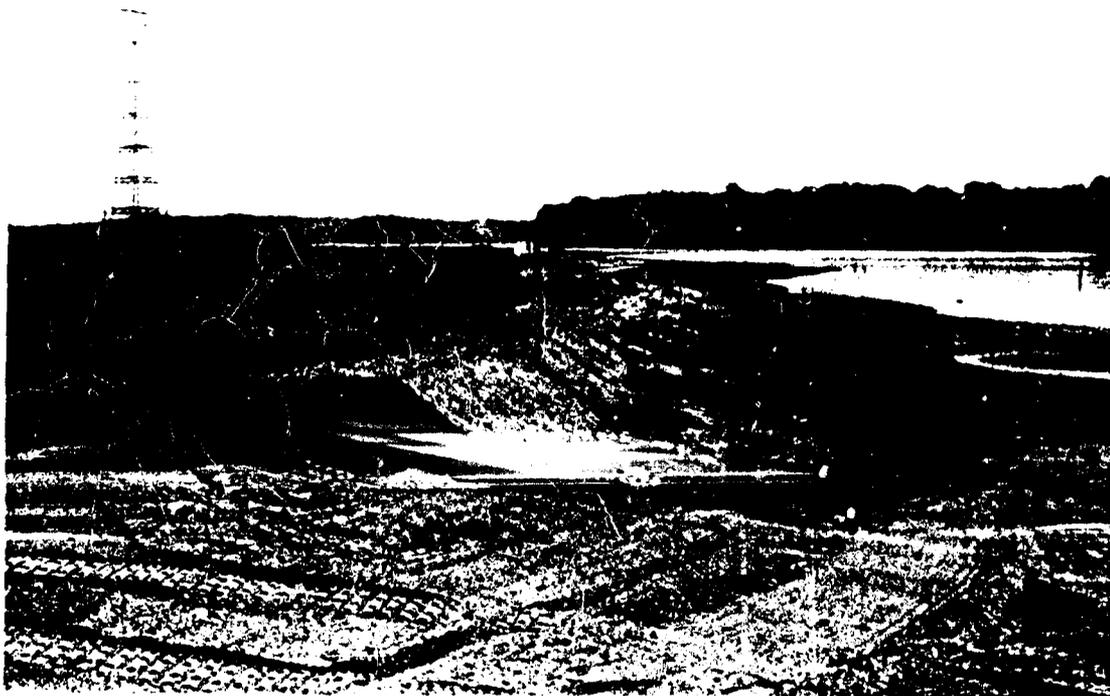
Figure 16. Graded and ungraded section of the south side of the dike.

Figure 16 shows a graded and ungraded section of the south side of the dike. Figures 17 and 18 show the north side of the dike before and after grading, respectively. All sections of the graded dike, with exception of the high elevation east side, were overtopped by spring tides (ca. 1-1.5 ft above MHW) approximately eight times per month.

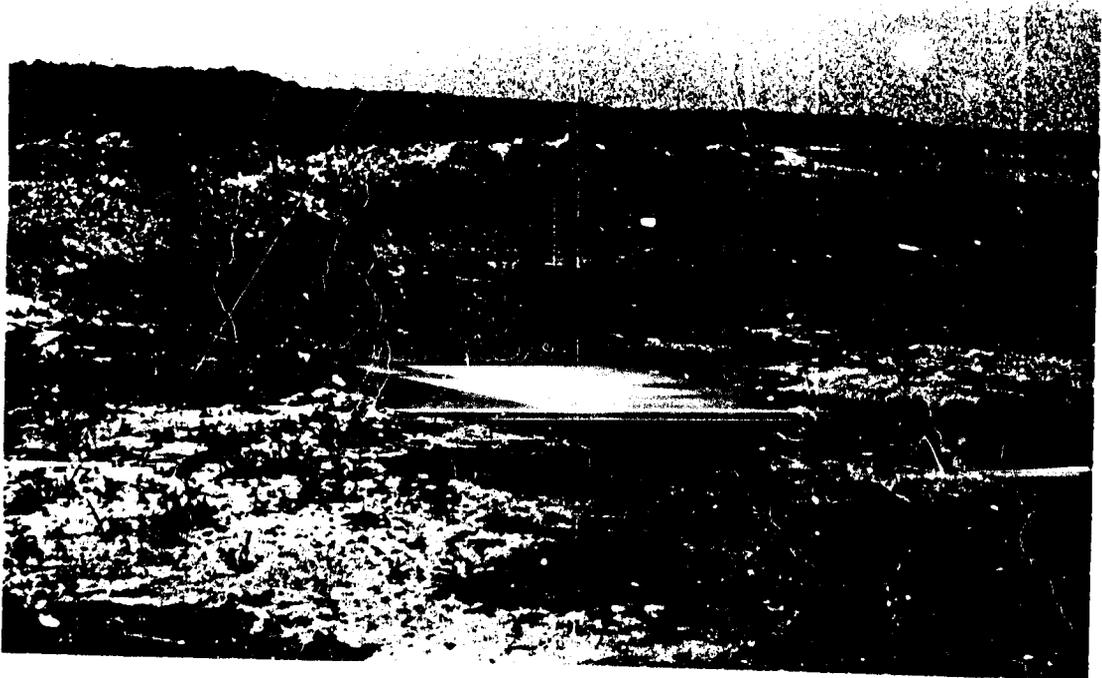
Figure 17. The north side of the dike looking west, before grading.

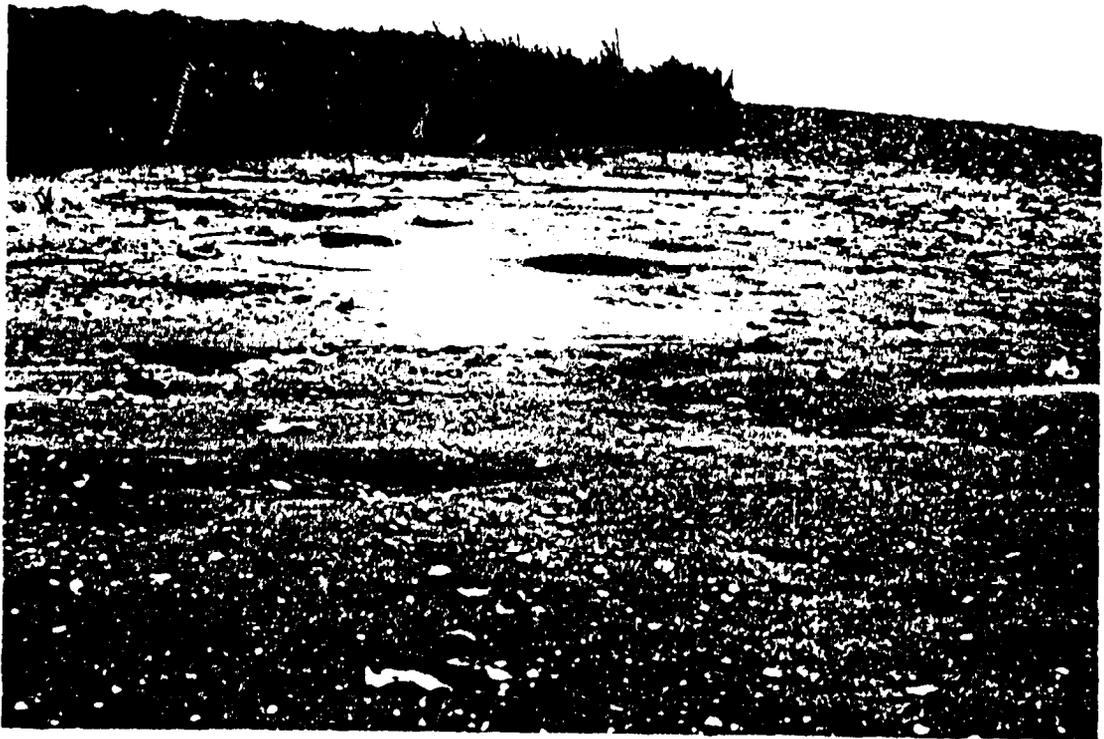
Figure 24. Depredated intertidal sand flat at the northeast end of the dike on 16 October 1975.

By 26 July, S. alterniflora and P. virginica seedlings were observed throughout the entire seeded area. At this time noticeable quantities of seeds of all four species had washed out and were being deposited in the area of the blocks of plots just southeast of the seeded area (see Fig. 2). On 29 August only the uppermost elevations of the seeded area (ca. 20% of total area) had any seedlings developing (see Fig. 21 and Fig. 20 for comparison). These seedlings were dominated by S. alterniflora with minor numbers of S. cynosuroides at the highest elevations and P. virginica throughout. By 16 October essentially all of these plants had been dug out by Canada geese (see Figs. 22 and 23) leaving the area covered with potholes (see Fig. 24) and strewn with excavated plant parts at the highest elevations (see Fig. 25).

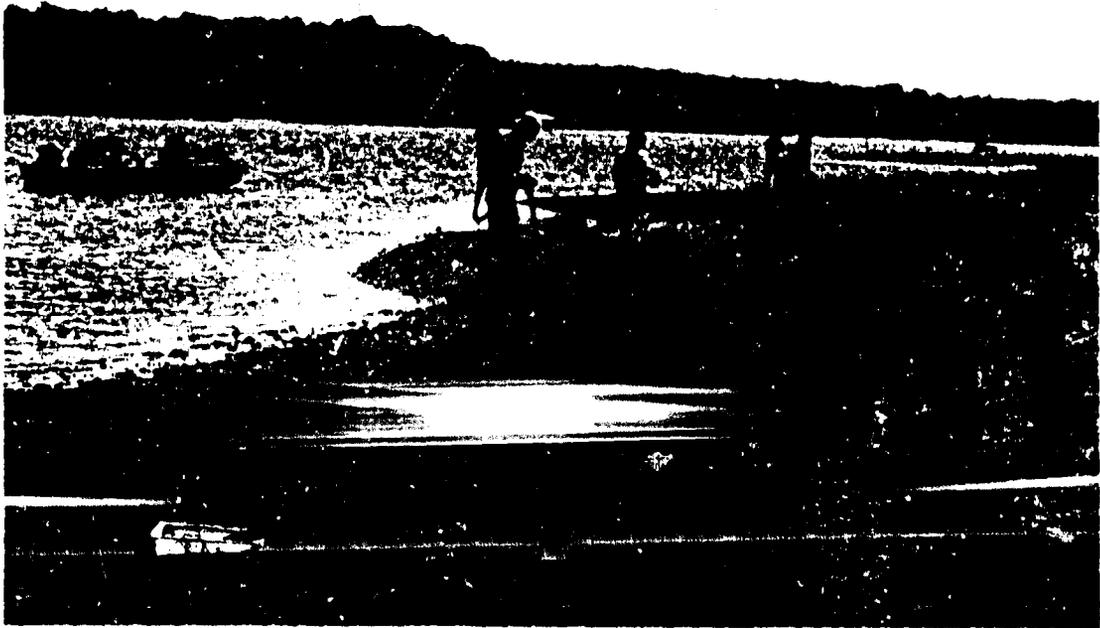
Figure 26. Transplanting S. alterniflora and S. americanus to the exterior intertidal area of the south side of the dike on 2 July 1975.

Transplanting was accomplished by machine augering a hole ca. 4 inches deep, placing 20 grams (ca. 1/2 fluid ounce) of OSMOCOTE 3- to 4-month release 19-6-12 fertilizer in the hole, and then planting the peat-potted S. alterniflora or group of

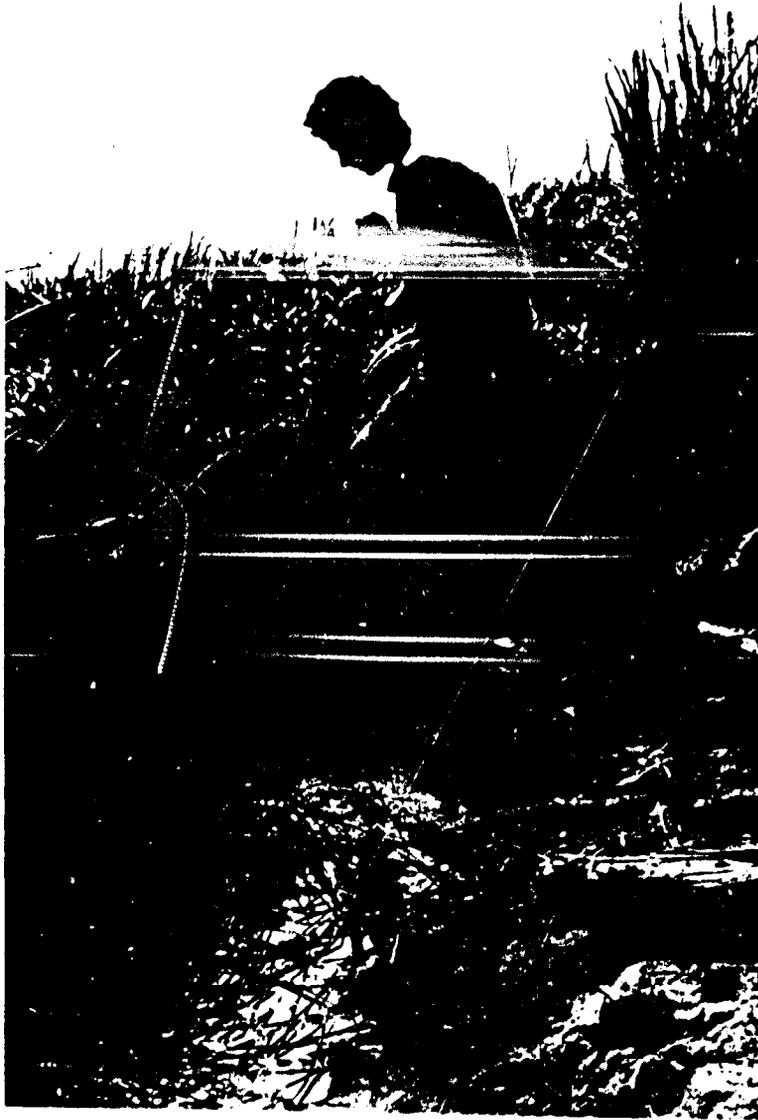
Figure 27. Excavating S. americanus near the Site on the James River.

The only naturally occurring S. americanus within six miles up-or downriver from the Site was a monotypic stand in sand and peaty substrates located on the south shore approximately two miles upriver from the Site. Transplant material was excavated from this site from 20 June through 9 July. Excavations were conducted at high tide to facilitate washing away the attached substrate (see Fig. 27). Single stems or groups of up to four stems were separated from the washed out clumps of plants or cut from the rhizome sections (see Figs. 28 and 29). Dead (dark brown) root parts were cut away, the top half of the mature (flowering) plants were clipped to provide ca. 18-inch tall transplants, and the plant materials stored in tubs of water until transplanting (see Fig. 30).

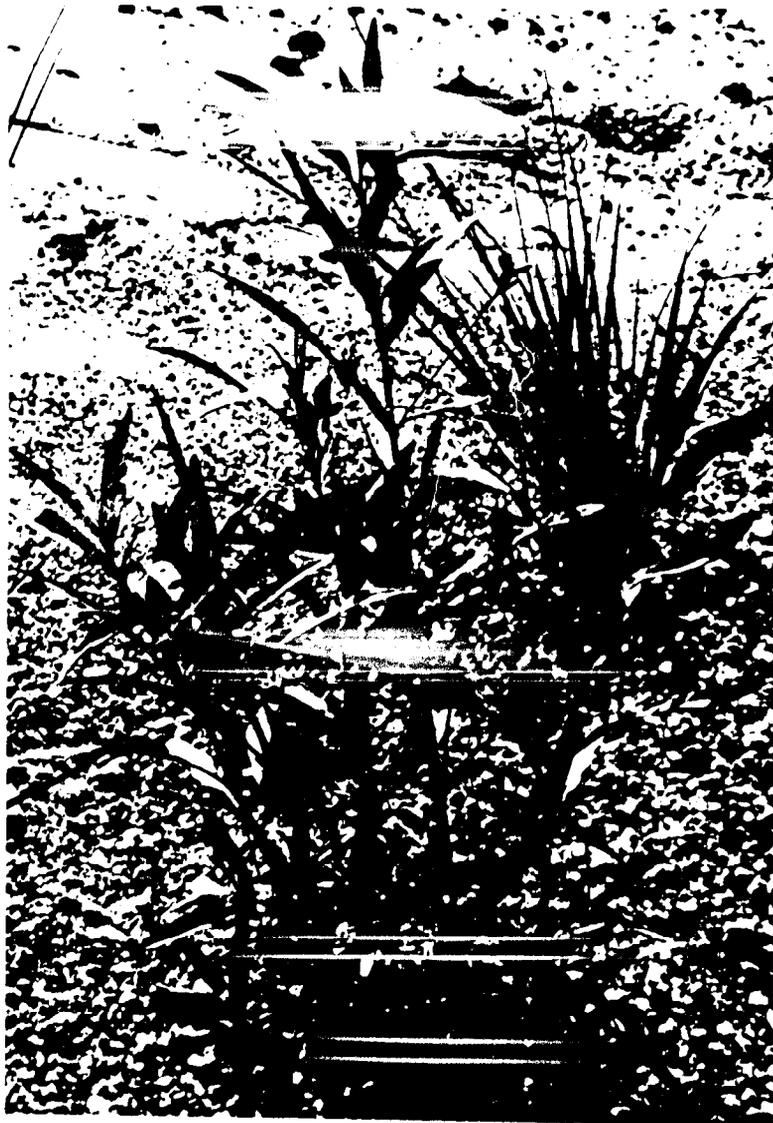
Figure 31. Transplant of D. verticillatus
two weeks after planting.

Although all bare root transplants survived and grew, Water Willow showed the most promise for ready establishment and rapid stabilization of sand and gravel intertidal sediments on relatively high wave energy freshwater shores. Figure 31 shows a D. verticillatus transplant on 20 July two weeks after planting and Figures 32 and 33 show partial rows of D. verticillatus transplants (arrow) on the south and west sides of the dike, respectively, on 16 October over three months after transplanting.

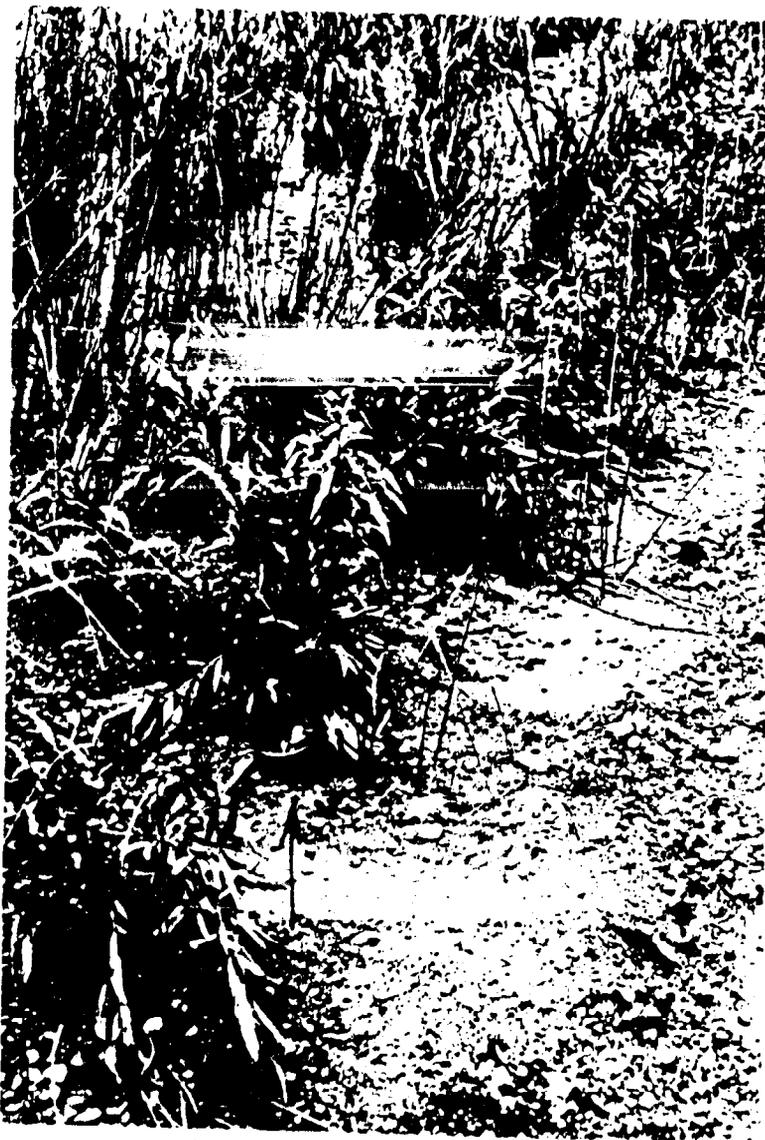
Figure 32. Partial row (arrow) of D. verticillatus transplants on the south side of the dike, over three months after planting.

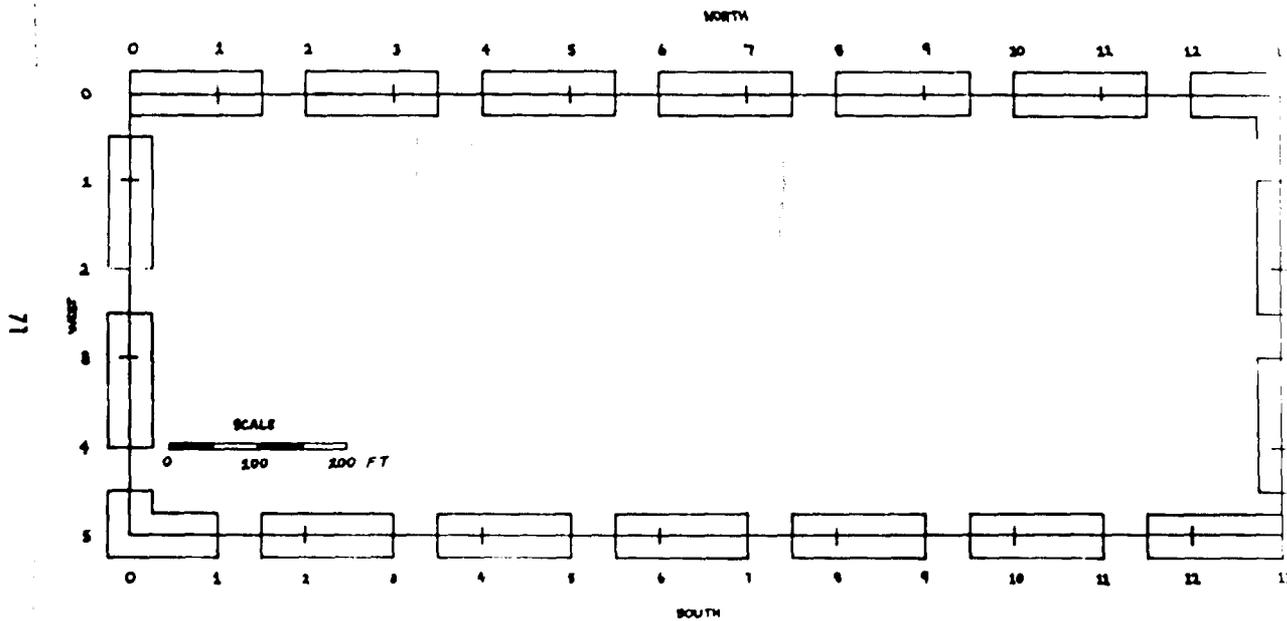
Figure 34. A schematic representation of the dike showing alternate 150 foot and 50 foot sections. The entire dike area was fertilized upon seeding during 24-30 July. Fertilizer was again applied to the 150 foot sections on 30 September.

On 16 October 1975, it was observed that most of the fertilized 150 foot sections of vegetation were clearly delineated by having greater chlorophyll pigmentation than the vegetation in the contiguous unfertilized 50 foot sections.

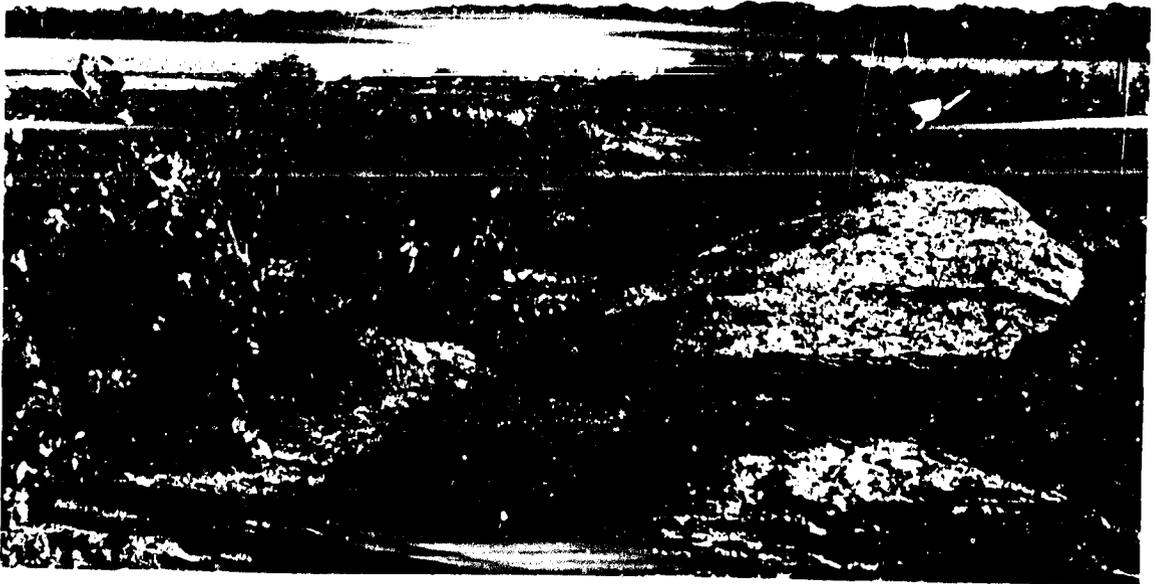
Figure 35. East end of the dike looking north before grading on 2 July 1975.

e. Overview of Dike Transplanting and Dike and Upland Area Seeding. Figures 35, 36, 37, and 38 show views of the east end of the dike looking north before grading on 2 July 1975, after grading and seeding on 31 July 1975, on 16 October 1975, and on 30 September 1976, respectively. By 30 September 1976 this area of the dike was dominated by P. amarulum and P. virgatum. Figures 39, 40, and 41 provide views at the east end of the dike looking south after seeding on 31 July 1975, on 16 October 1975, and on 30 September 1976, respectively. By the latter date, this area was dominated by P. amarulum and P. virgatum.

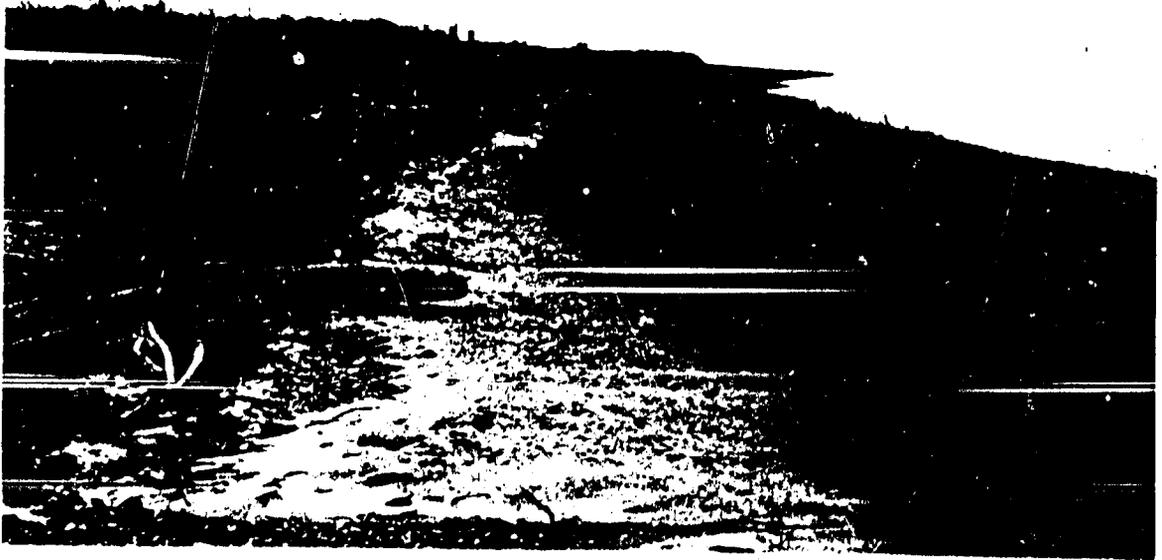
Figure 49. Mid-north side of the dike looking west along the fringe marsh on 16 October 1975.

Figures 48, 49, and 50 show views at the mid-north side of the dike looking west along the fringe marsh on 31 July 1975, 16 October 1975, and 30 September 1976, respectively. The band of S. alterniflora and S. americanus shown in these figures is the only significant fringe marsh remaining on 30 September 1976 at the Site. Extensive Canada geese "eat-out" during the winter of 1976 led to the loss of most of the balance of the fringe marsh along the dike exterior.

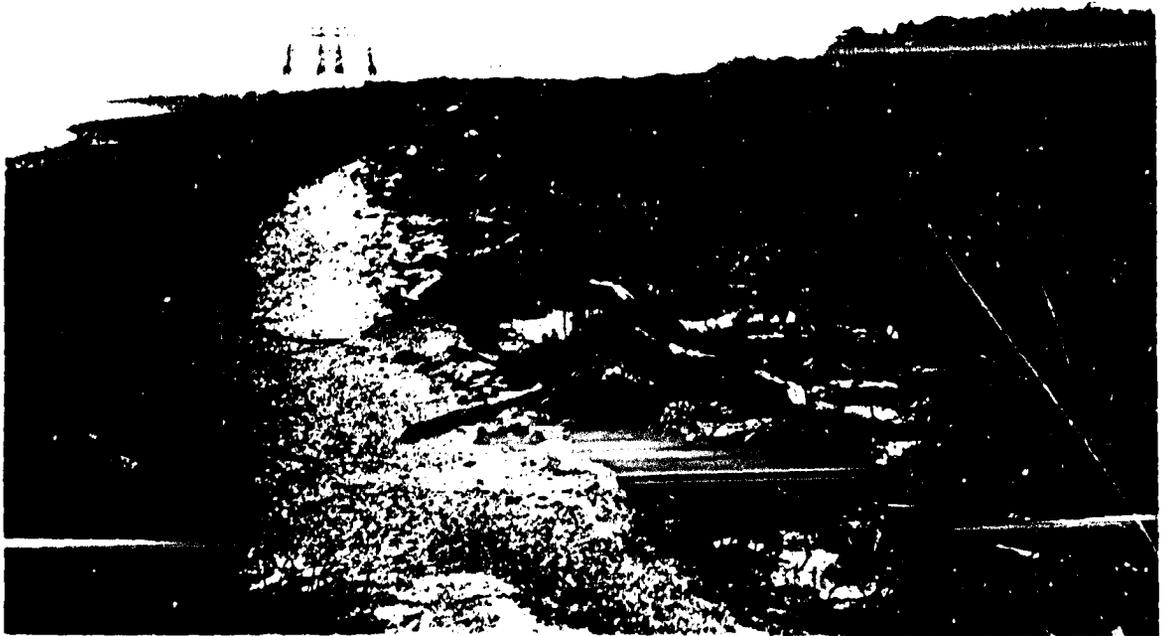
Figure 52. Mid-north side of the dike looking east along
the seeded area on 16 October 1975.

Views at the mid-north side of the dike looking east along the seeded portion on 29 August 1975, on 16 October 1975, and on 30 September 1976 are provided in Figures 51, 52, and 53, respectively. Note the sections of P. virginica marsh deposited on the highest elevations of the dike in the foreground and background of Fig. 51. Eroded sections of P. virginica marsh were frequently observed floating downriver (see Fig. 54). Seeds and seedlings of P. virginica also were noted floating downriver and many of these were deposited throughout the Site. The view in Figure 53 is dominated by P. amarulum and tall

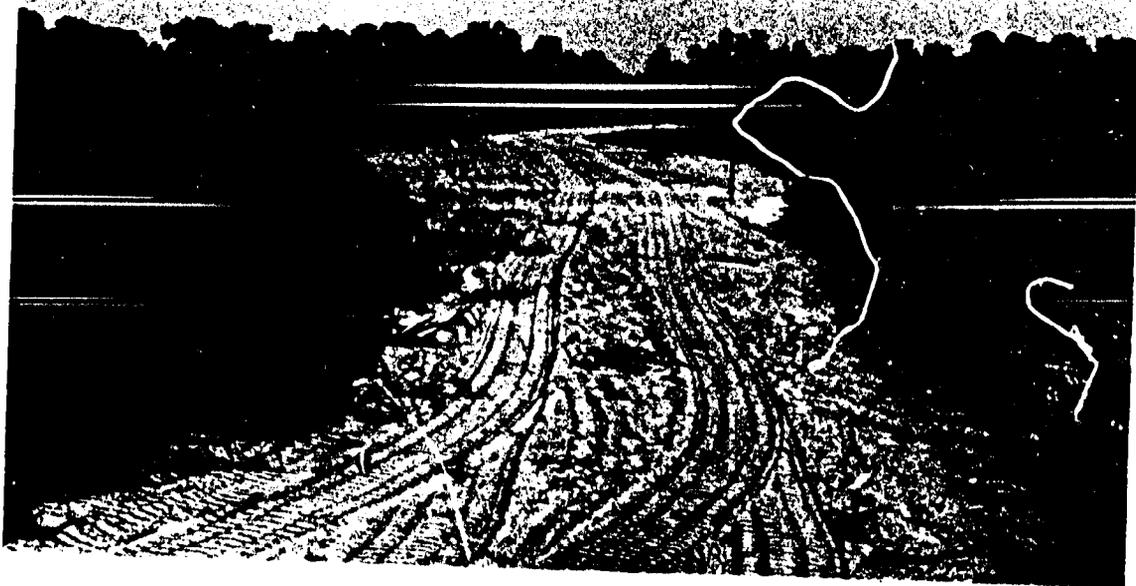
Figure 55. Northwest corner of the dike looking south along the west side on 31 July 1975.

Views of the west end of the dike from the northwest corner looking south on 31 July 1975, on 16 October 1975, and on 30 September 1976 are shown in Figures 55, 56, and 57, respectively. The vegetation seen in Figure 57 is dominated by P. amarulum. The volunteer marsh on the contained dredged materials, as viewed on 31 July 1975 from the mid-west end of the dike looking east, is shown in Figure 58. The person in this figure is 5 feet 4 inches tall and the dominant vegetation seen is P. cordata.

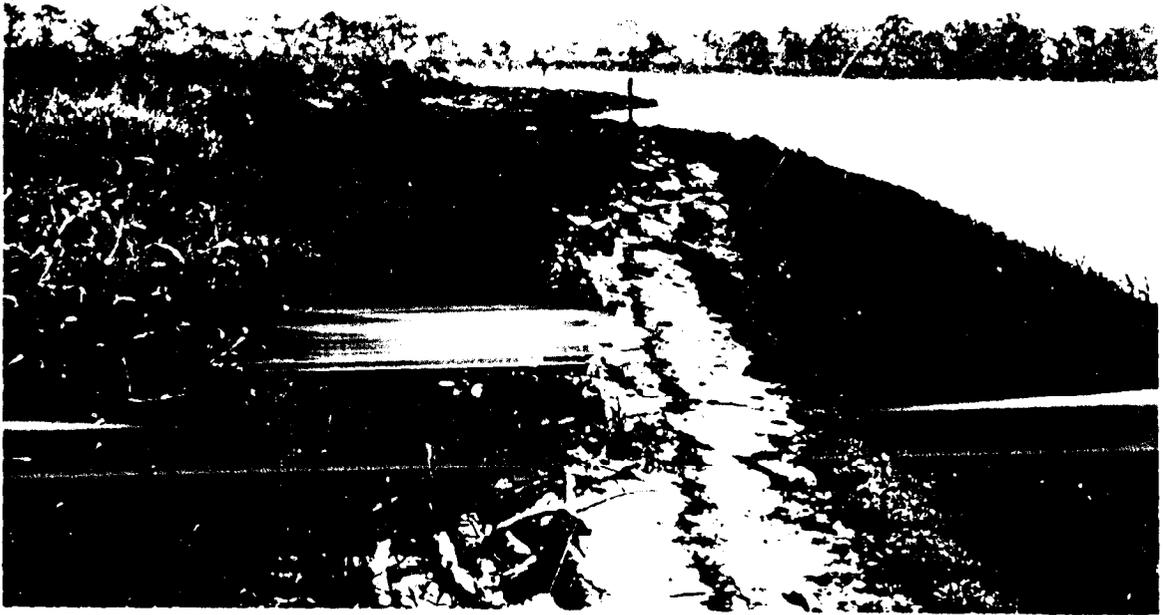
Figure 56. Northwest corner of the dike looking south along the west side on 16 October 1975.

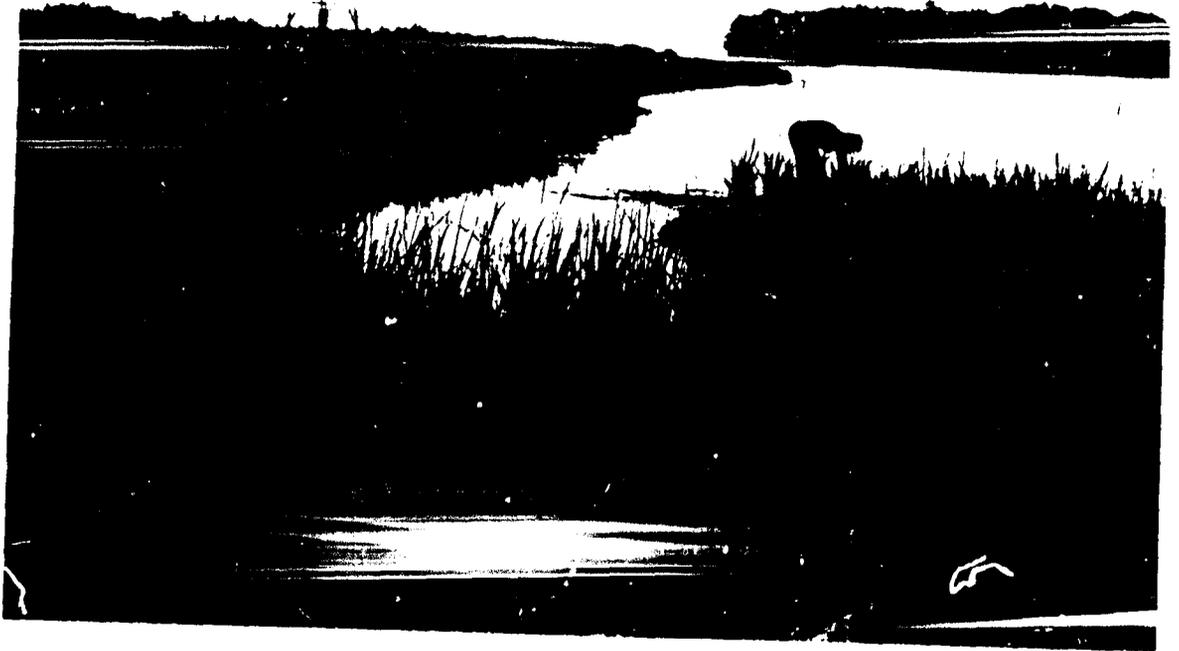
Figure 60. Looking east at the fringe marsh along the exterior southern side of the dike from the southwest corner on 16 October 1975.

The marsh fringe along the exterior southern side of the dike, as seen on 31 July 1975, 16 October 1975, and 30 September 1976 from the south, looking east, is shown in Figures 59, 60, and 61, respectively. Approximately 80% of the marsh, as seen in Figure 60, was "eaten-out" during the winter of 1976 and is missing in Figure 61.

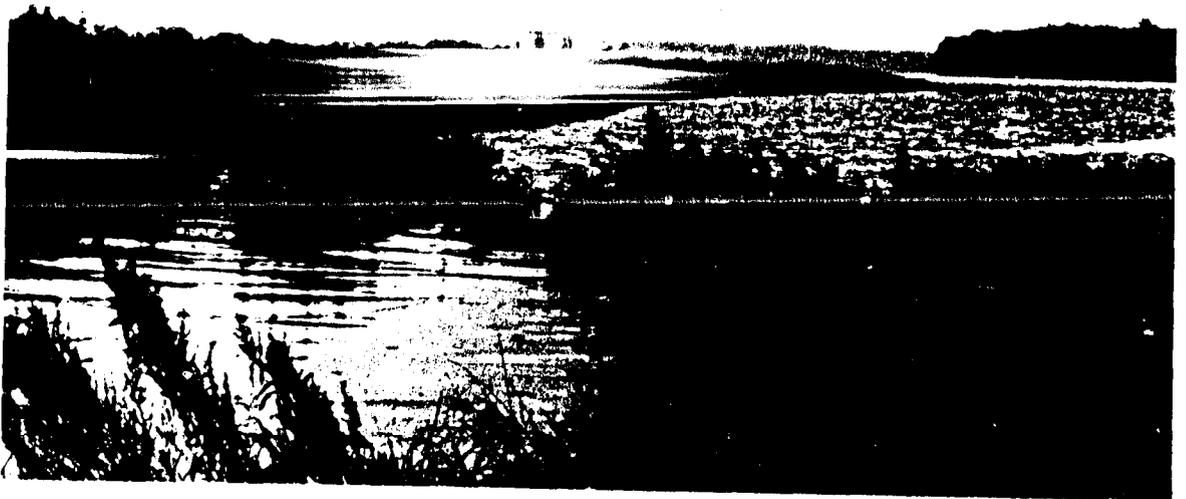
Figure 61. Looking east at the fringe marsh along the exterior southern side of the dike from the southwest corner on 30 September 1976.

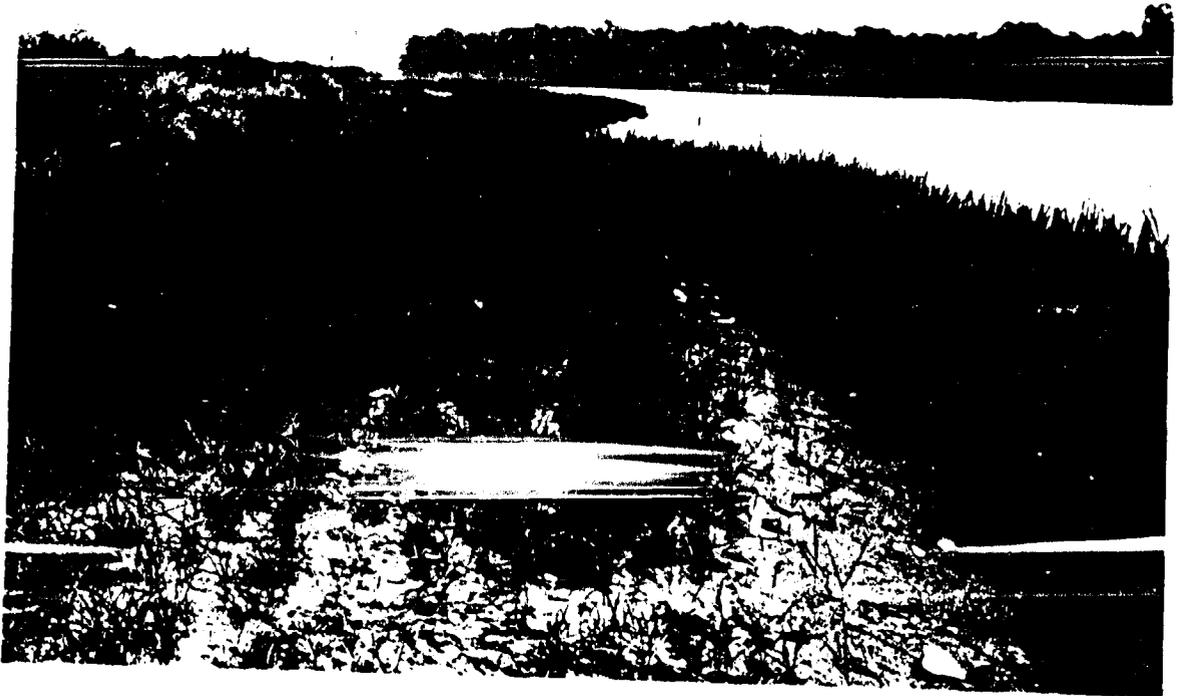
Figure 63. Looking east from the mid-south side of the dike
on 16 October 1975.

Views of the seeded portion of the dike looking east from the mid-south side on 31 July 1975, on 16 October 1975, and on 30 September 1976 are shown in Figures 62, 63, and 64, respectively. The dominant vegetation seen in Figure 64 is P. amarulum. Views looking west from the mid-south side of the dike on 29 August 1975, on 16 October 1975, and on 30 September 1976 are provided in Figures 65, 66, and 67, respectively. Note the complete loss of the fringe marsh on the dike exterior

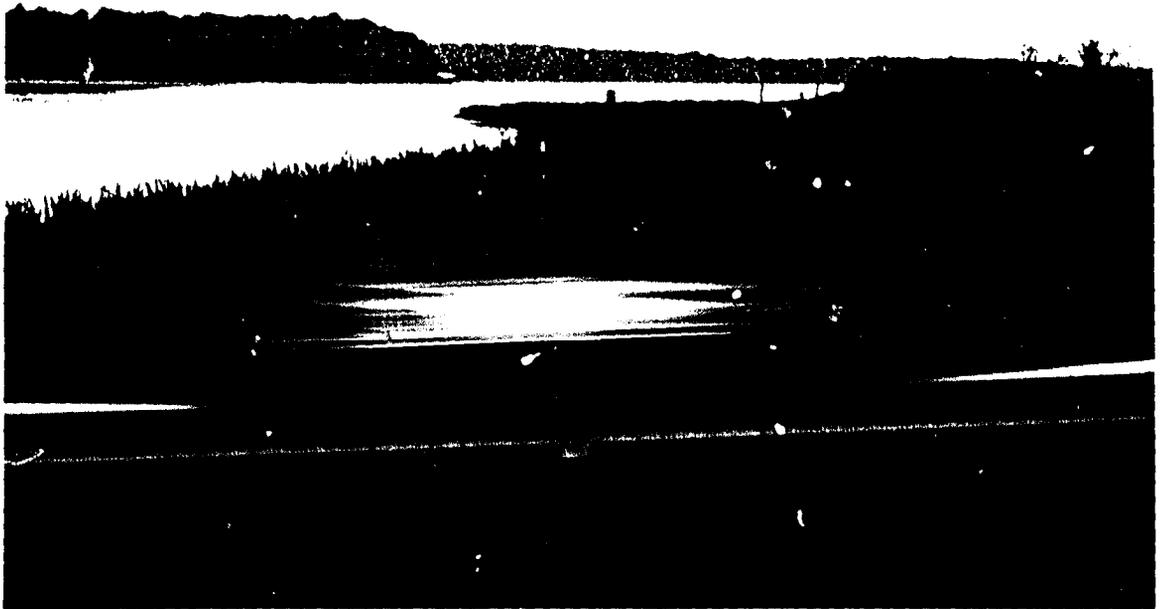
Figure 66. Looking west from the mid-south side of the dike
on 16 October 1975.

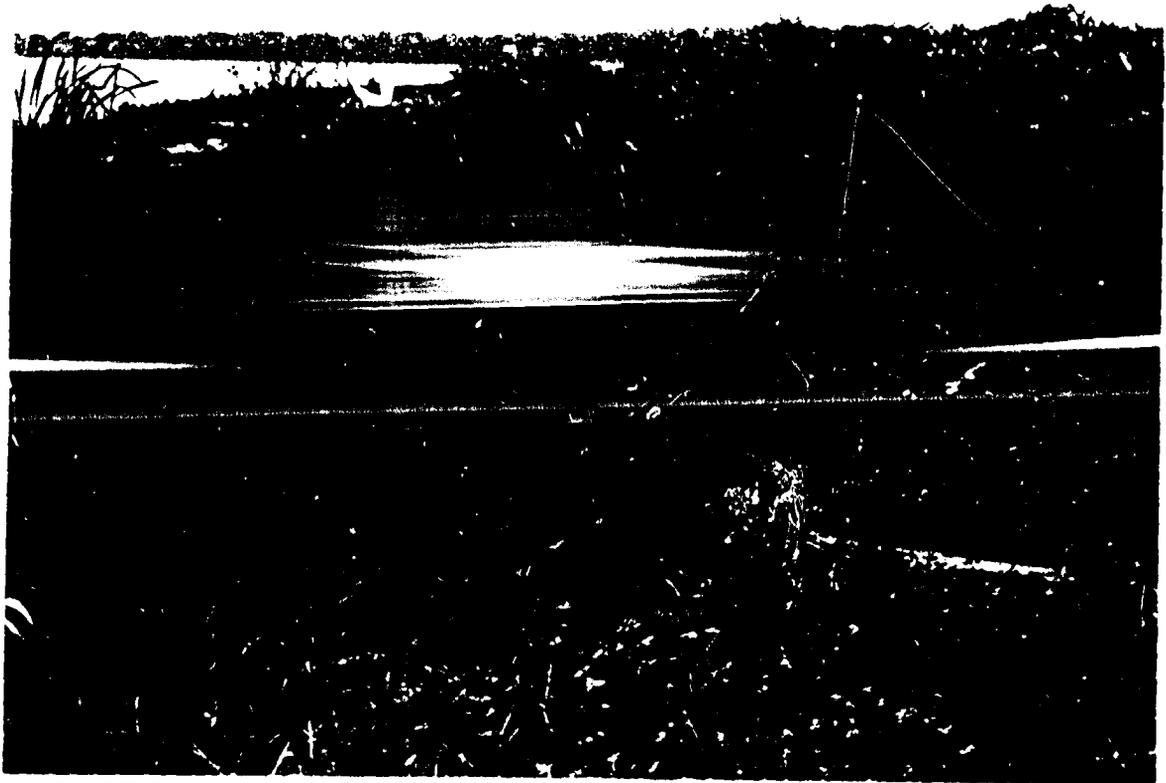
Figure 68. A section of the interior south side of the dike that is dominated by I. repens on 16 October 1975.

Portions of the south and north dike interiors that were seeded to I. repens, D. glomerata, and F. elatior and that were essentially monotypic I. repens on 16 October 1975 are shown in Figures 68 and 69, respectively. A greater diversity of plants were present in these areas on 30 September 1976.

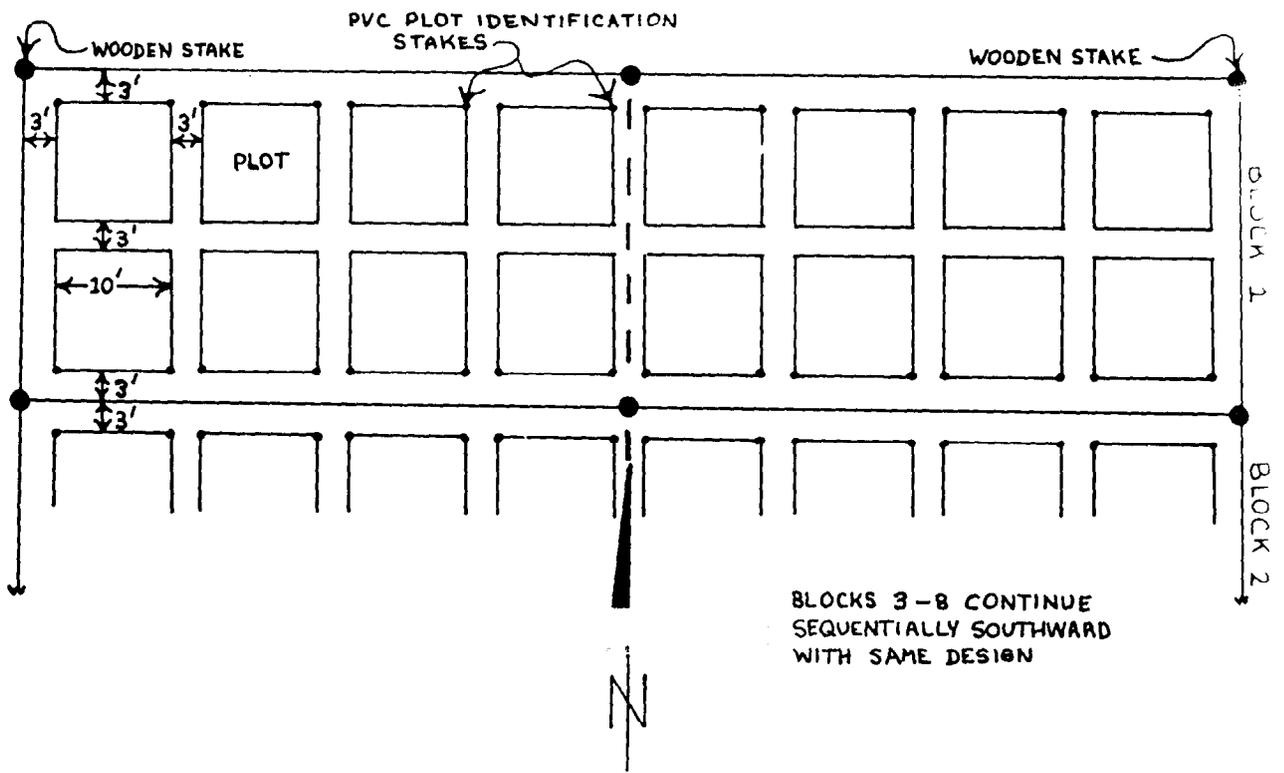
Figure 70. A schematic representation of the physical design of the blocks of plots.

Eight replicated blocks of 16 plots of seeded and sprigged marsh plants were established on the unconfined dredged materials just east of the northeast side of the dike (see Fig. 2). The physical and statistical design of these blocks of plots were provided by WES and are indicated in Figures 70 and 71. Each 10' X 10' plot contains 49 replicated treatments on 1.25 foot centers. The block of plots were staked out on July 12th and 13th from the approximate Mean Tide (+1.3 ft relative to MLW) at the eastern ends of the blocks to approximately MHW (+2.5 ft relative to MLW) at the western ends. Mean Tide and MHW elevations throughout the area of the blocks of plots were qualitatively determined by placing stakes at the water-land interface at the time predicted (tide tables) for high tide at Jordan Point (ca. 9 miles upriver from the Site) and at 3 hrs after this time (for approx Mean Tide) on a day when high tide was predicted to be at MHW.
