TECHNICAL REPORT D-77-23

HABITAT DEVELOPMENT FIELD INVESTIGATIONS
WINDMILL POINT MARSH DEVELOPMENT SITE
JAMES RIVER, VIRGINIA

APPENDIX B: PROPAGATION OF VASCULAR PLANTS

HABITAT DEVELOPMENT FIELD INVESTIGATIONS, WINDMILL POINT
MARSH DEVELOPMENT SITE, JAMES RIVER, VIRGINIA

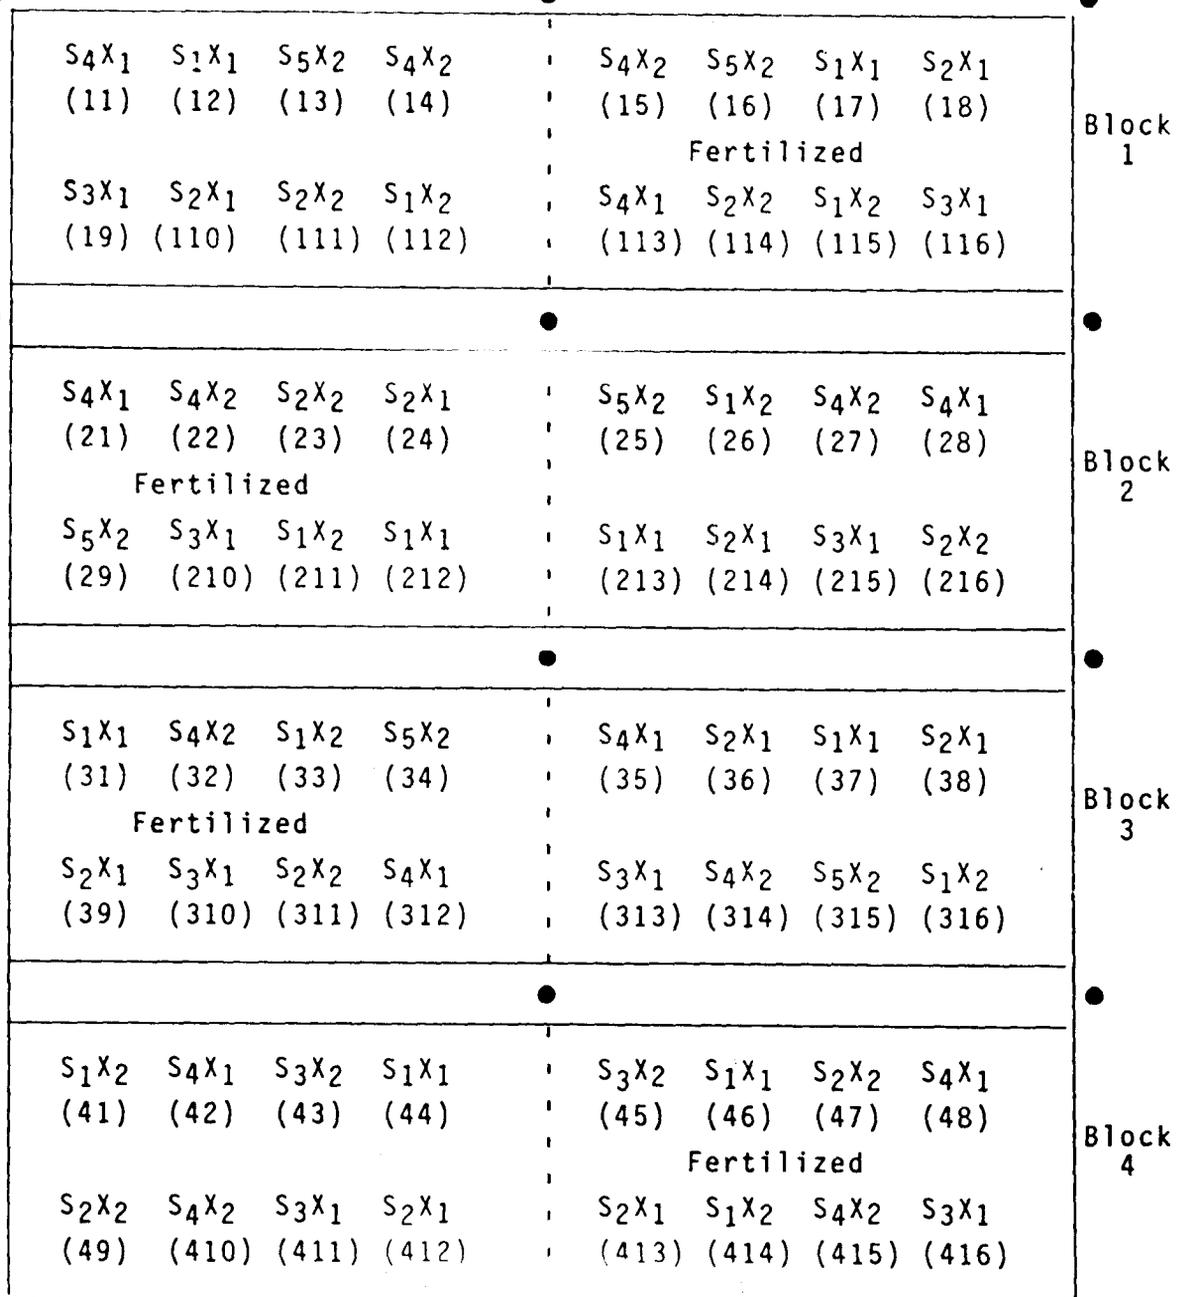
Figure 71. A schematic representation of the statistical design of the blocks of plots. Parenthetical numbers represent those placed twice on each of the two PVC plot identification stakes (see Fig. 70). X₁ = sprigging, X₂ = seeding, S₁ = *P. virginica*, S₂ = *S. cynosuroides*, S₃ = S₅ = *S. robustus*, S₄ = *S. alterniflora*. Blocks 5, 6, 7, and 8 are identical to blocks 1, 2, 3, 4, respectively, and continue sequentially in a southerly direction. The PVC plot identification stake numbers for these plots follow the scheme shown for Blocks 1-4.

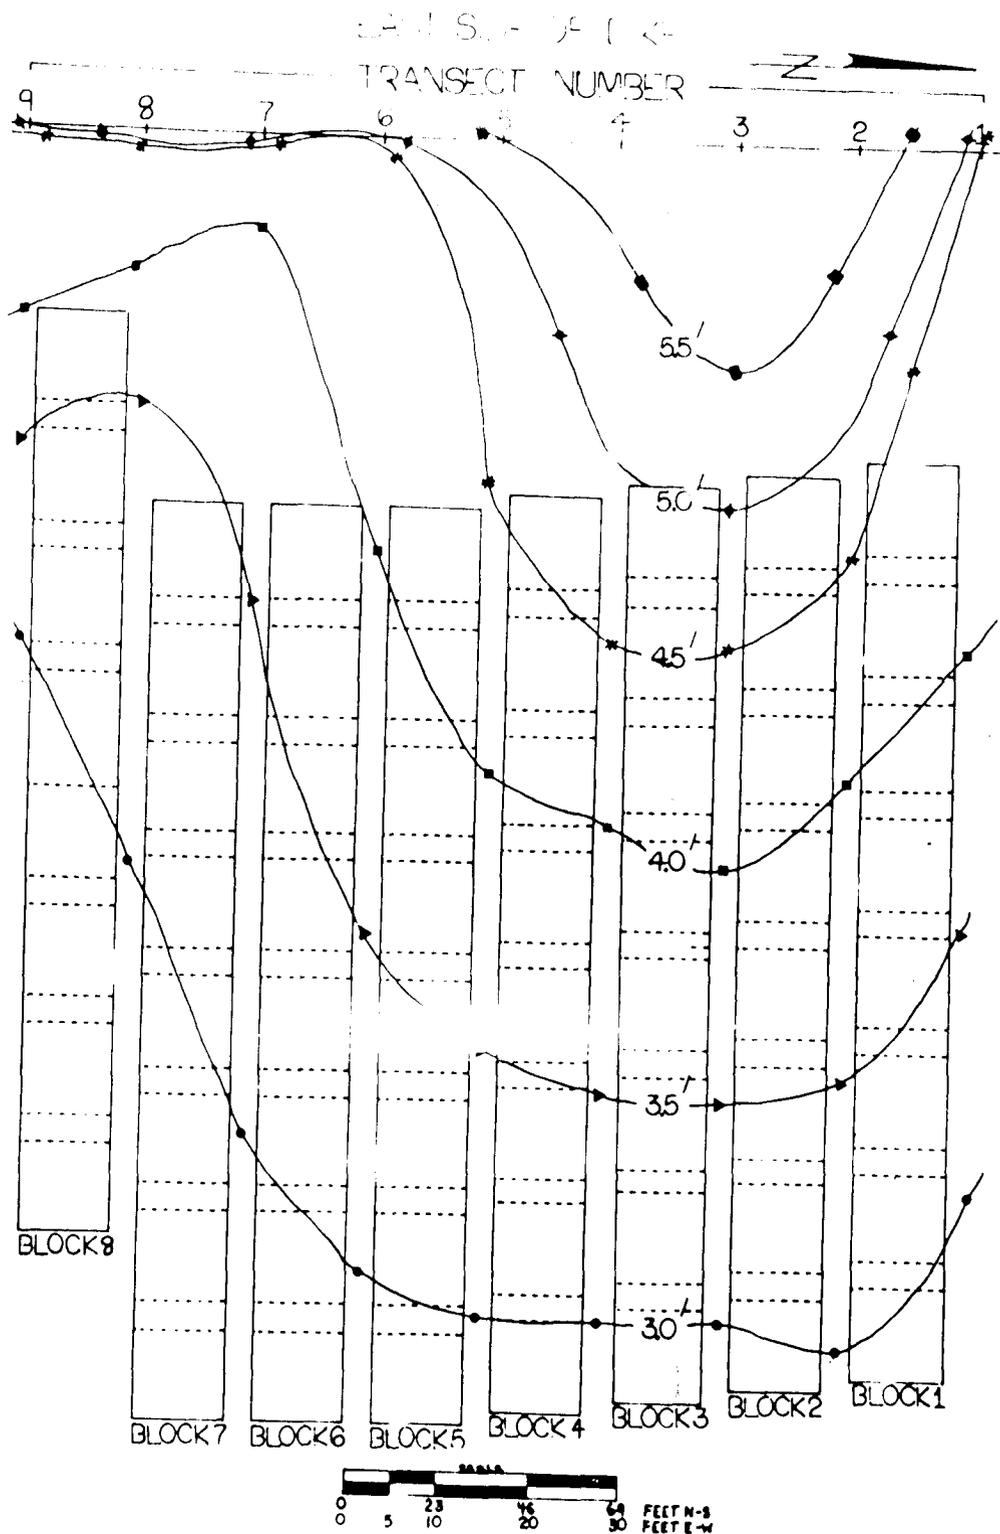
Figure 72. Elevation contours (0.5 ft) relative to CE MLW as zero throughout the blocks of plots.

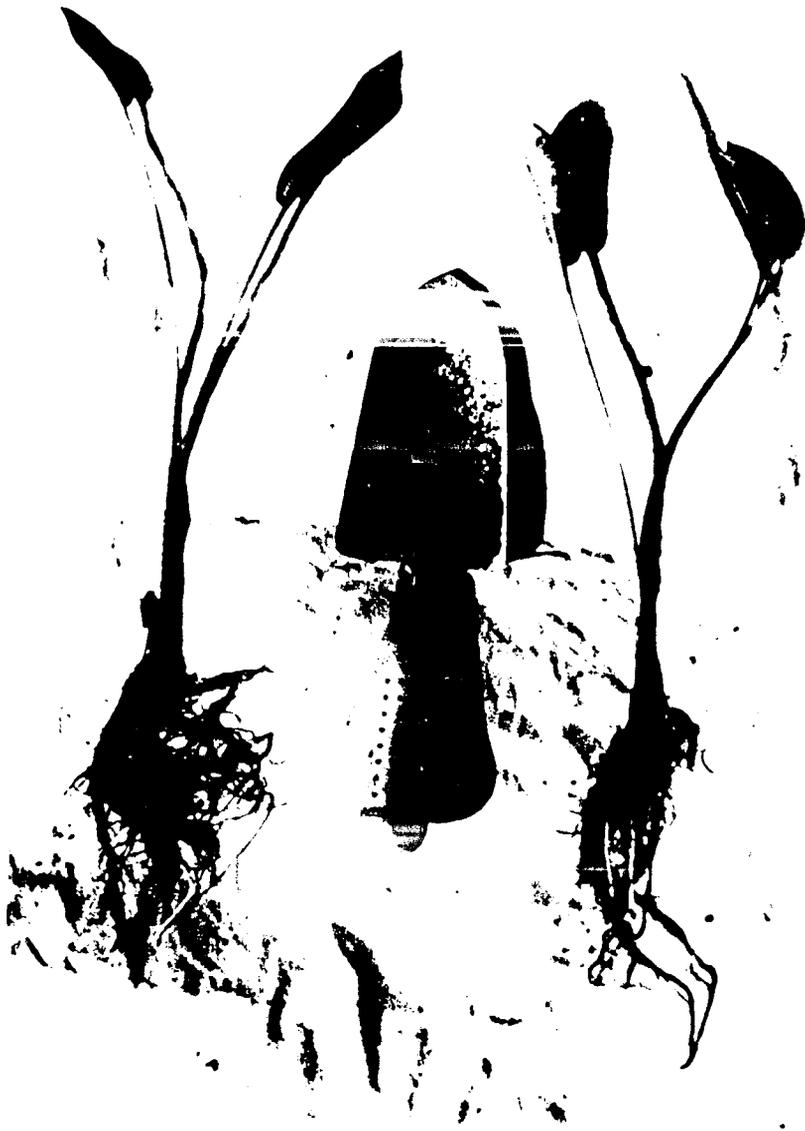
Figure 74. Representative specimens of P.
virginica transplanted to the
blocks of plots.

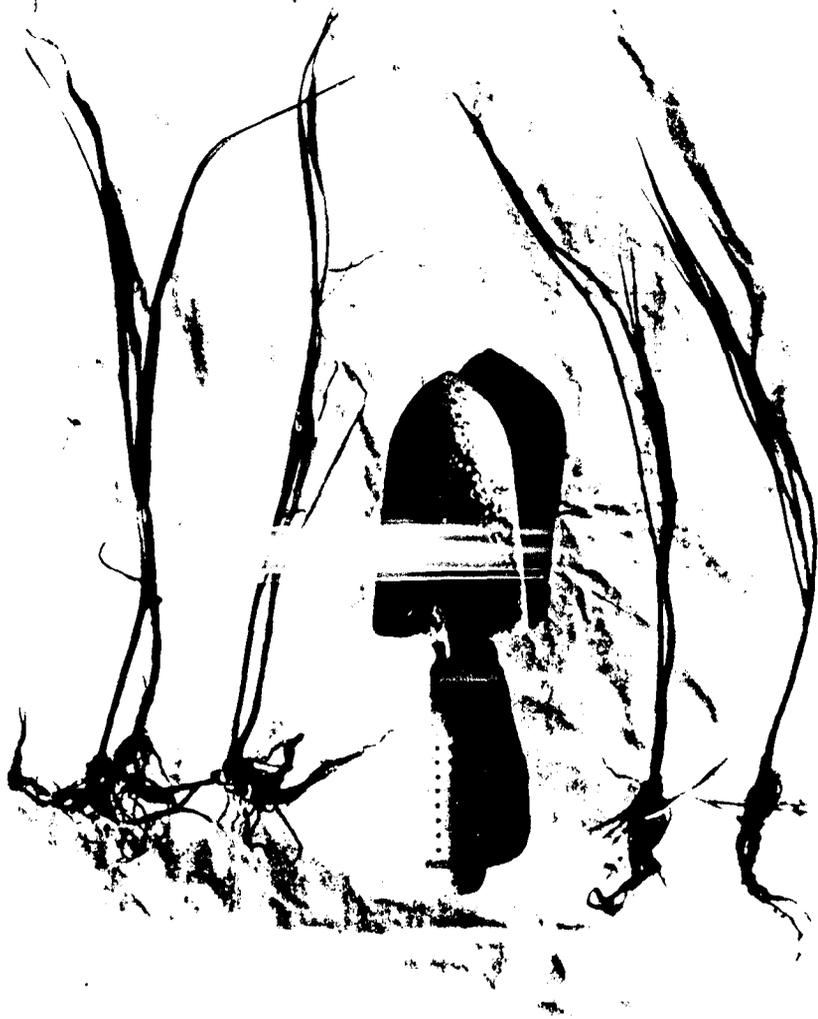
Figure 75. Representative specimens of S.
robustus transplanted to the
blocks of plots.

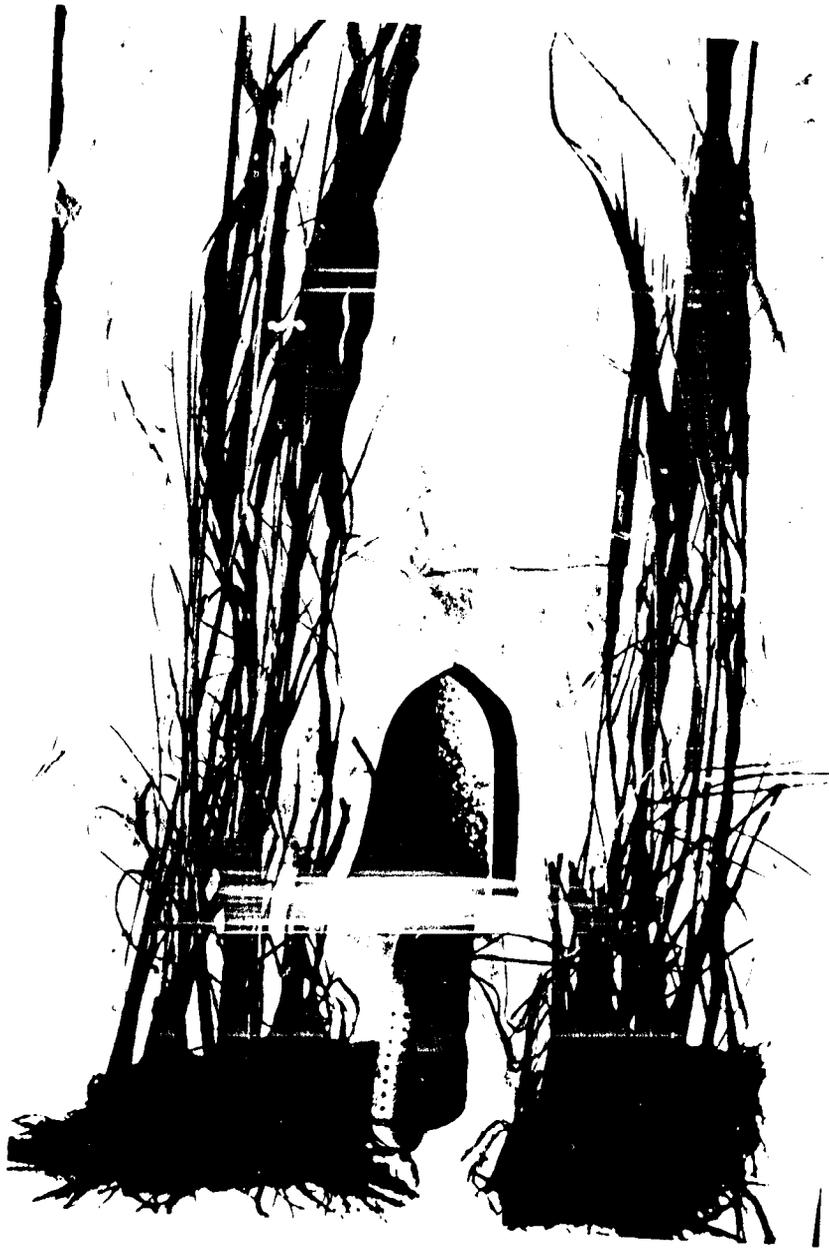
Figure 76. Representative specimens of *S.*
cynosuroides transplanted to the
blocks of plots.

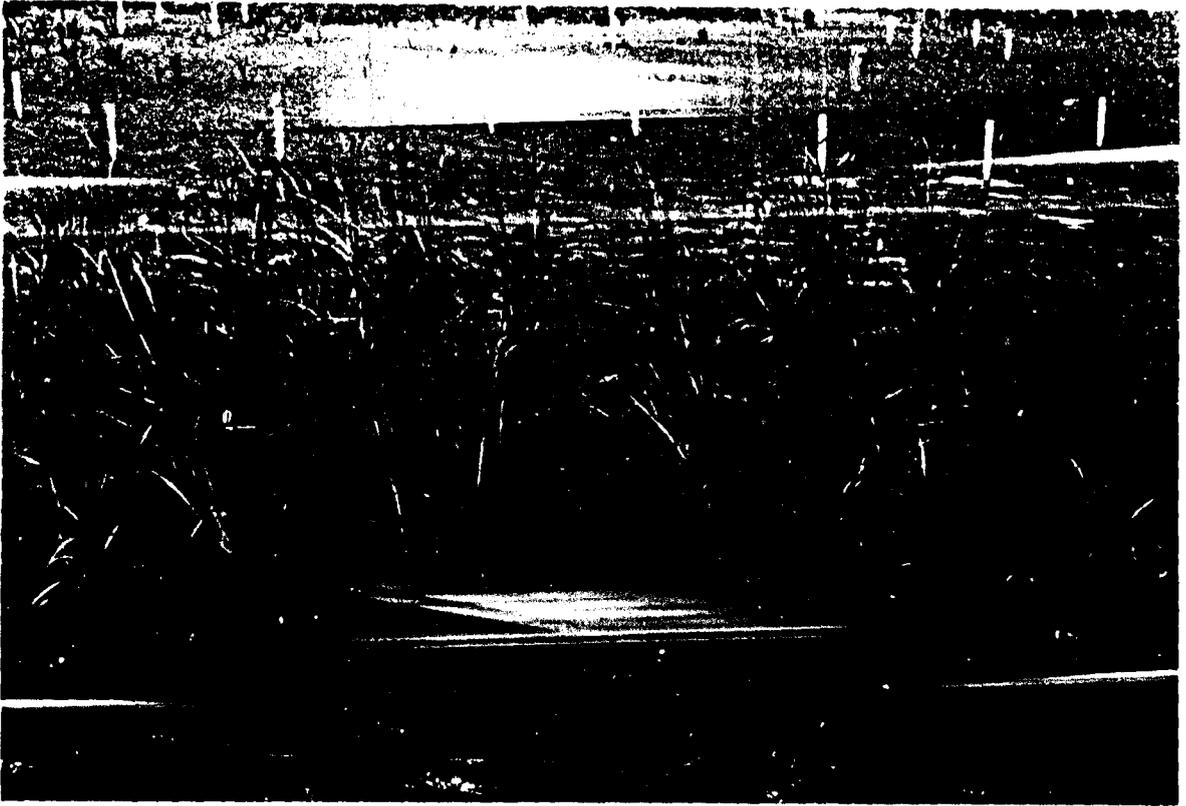
Figure 81. Animal excavations at the base of S. cynosuroides in sprigged plots as seen on 29 August 1975.

It is thought that shorebirds were responsible for the extensive clipping of the aboveground parts of the plants. Fish may have been responsible for the shallow symmetrical excavations at the lower elevations as shown in Figures 80 and 81. The deeper and more extensive excavations shown in Figures 80 and 86 through 89 may have been caused by Canada geese, which were on and about the Site in large numbers by September. Goose and duck footprints and droppings were abundant throughout the blocks of plots and plant excavation sites were literally covered by shorebird tracks on 16 October.

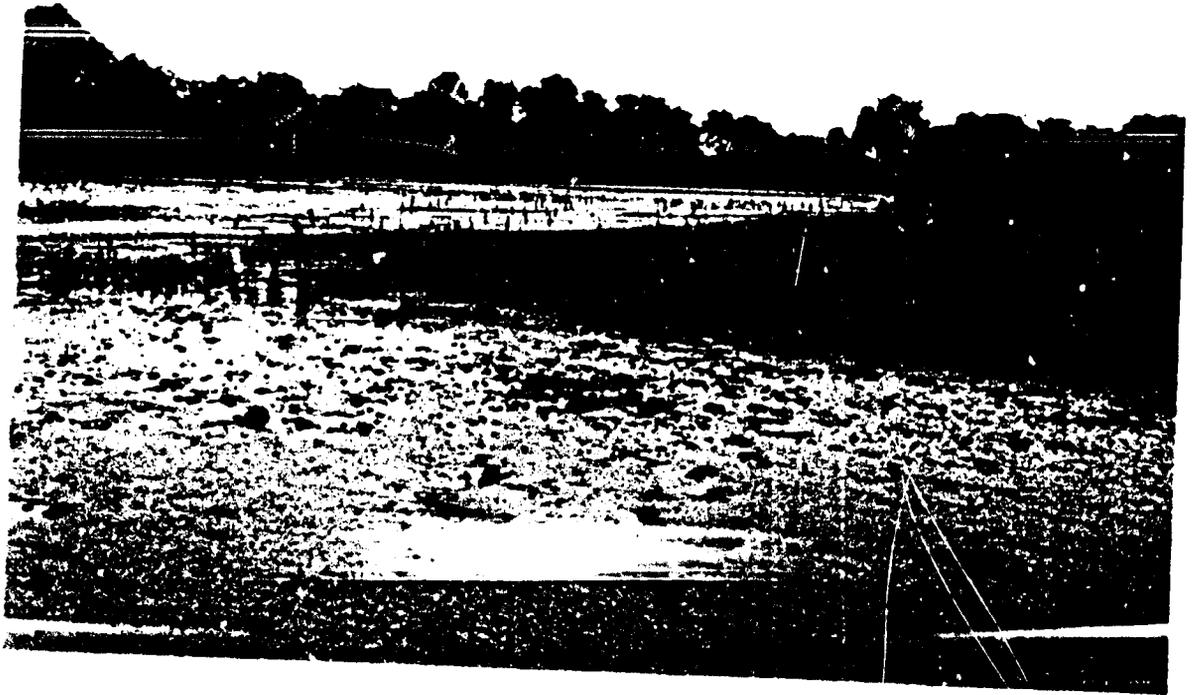
Figure 85. The barren lowermost and mid-elevations of the eight blocks of plots as viewed from the northeast corner of the dike looking south on 16 October 1975.

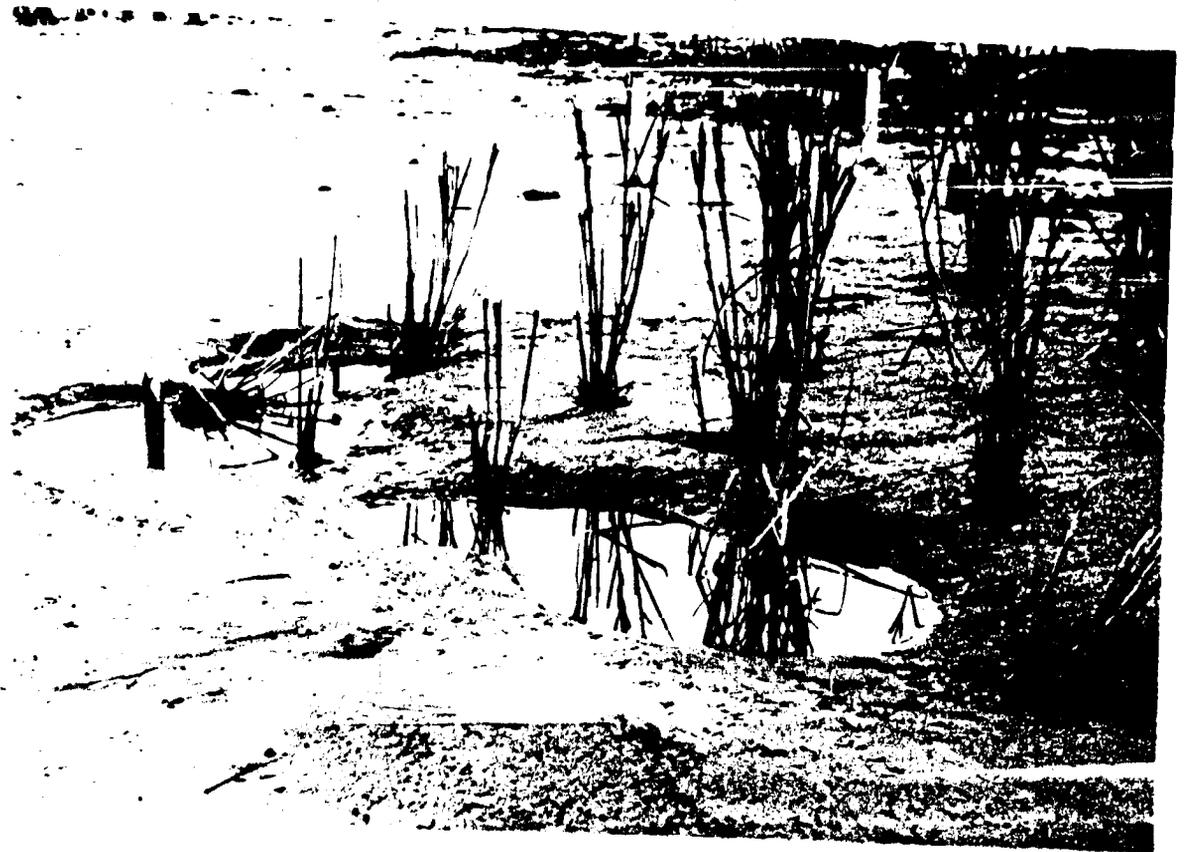
Figure 89. Plant excavations in the plots as seen on 16 October 1975.

On 16 October, the damage was more extensive and no plots were unaffected. Figure 86 through 89 show the extent of the damage. Note the extensive shorebird tracks shown in Figure 88. By 30 September 1976, one year later, only one plot of S. alterniflora transplants (plot 113) and one plot of S. cynosuroides transplants (plot 24) out of the total of 128 plots had any planted vegetation visible (see Figs. 90 and 91).

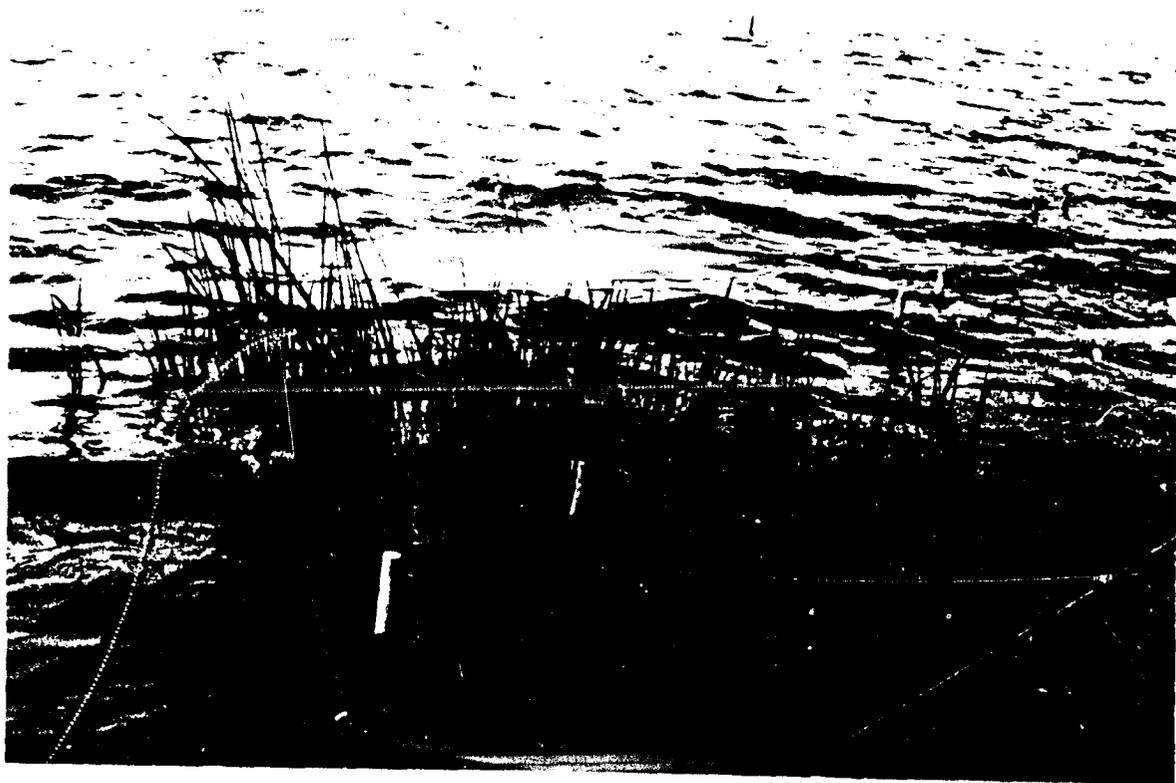
Figure 90. S. alterniflora in sprigged plot 113 as seen on 30 September 1976. This is one of the two plots where planted vegetation remained.

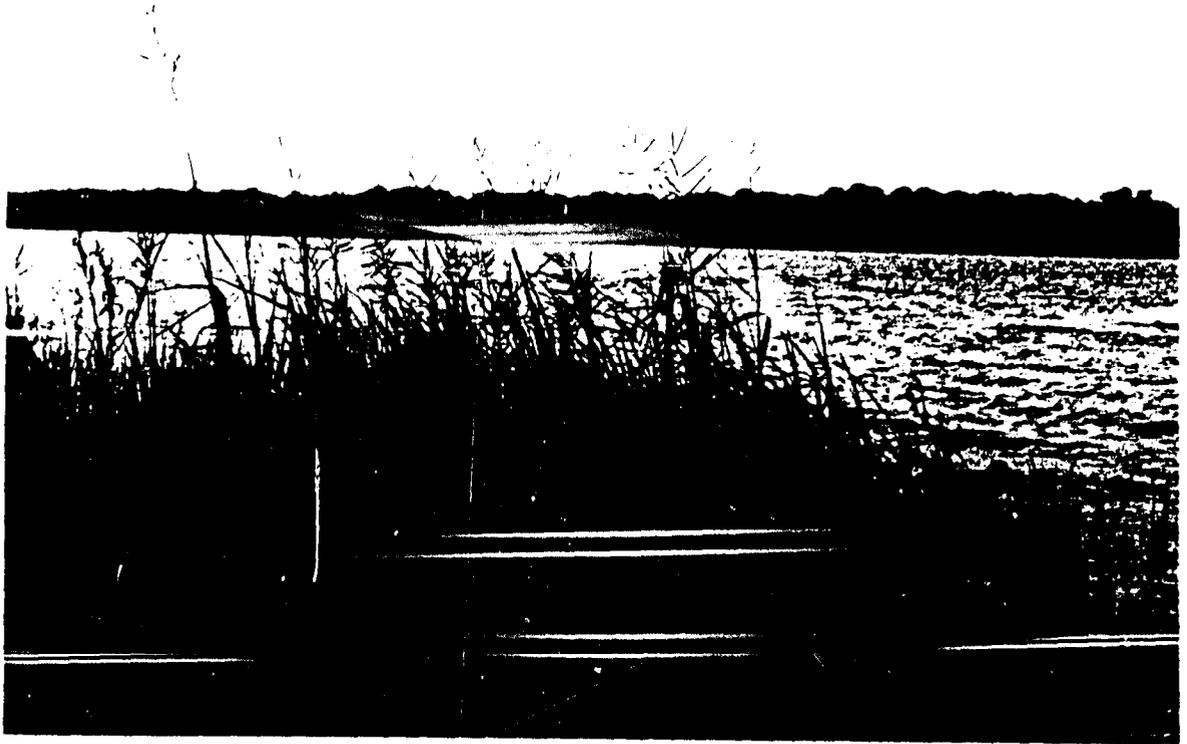
Figure 91. S. cynosuroides in sprigged plot 24 as seen on
30 September. This is one of the two plots
where planted vegetation remained.
