ERDC/EL TR-15-5

# **Characterization of Suspended Sediment Plumes Resulting from Barge Decanting in San Francisco Bay**

June 2015

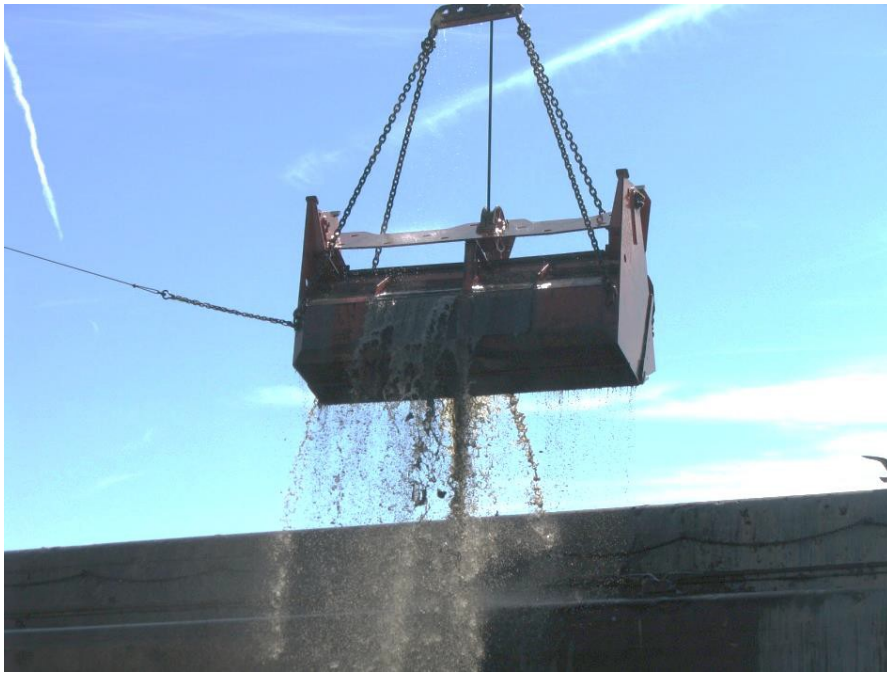
Figure 2. Fourteen cyd closed environmental bucket used by the Dredge *DB Palomor* in the Port of Richmond.

Dredging was conducted by the *DB Palomor* using a 14-cubic yard closed environmental Cable Arm® bucket (Figure 2) operated by RES Engineering, Inc. The dredge has a 75-ton capacity crane with barge dimensions of 150' x 54' x 13'. For position maneuvering, it has the capability of using two 80' spuds or four anchors and buoys. The latter anchoring technique was used during the present study.

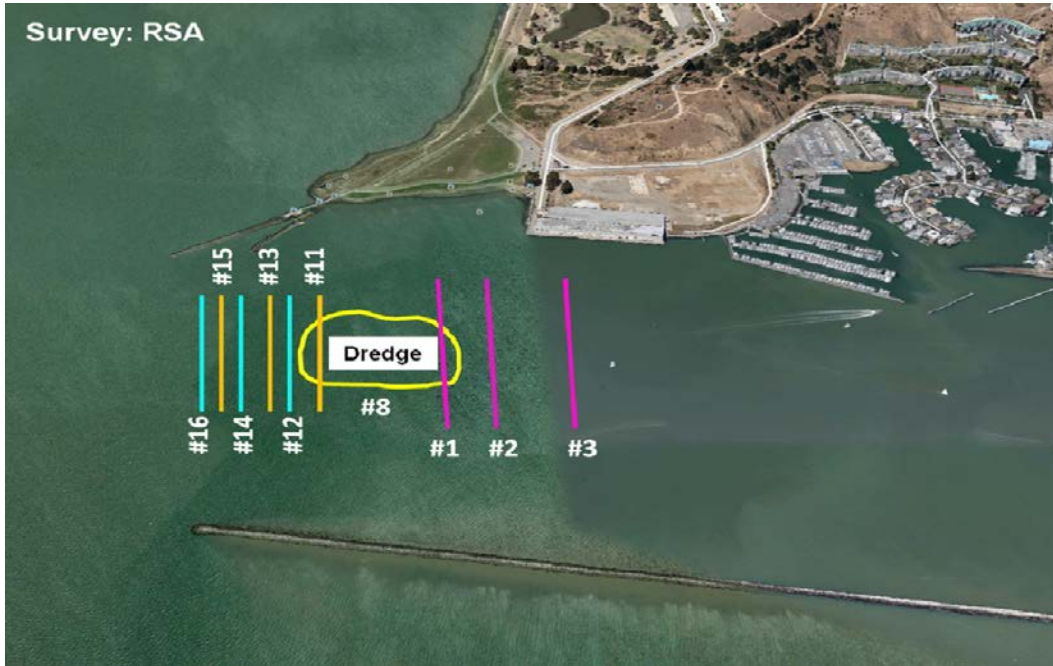
Figure 4. Layout of transects for Survey RSA.

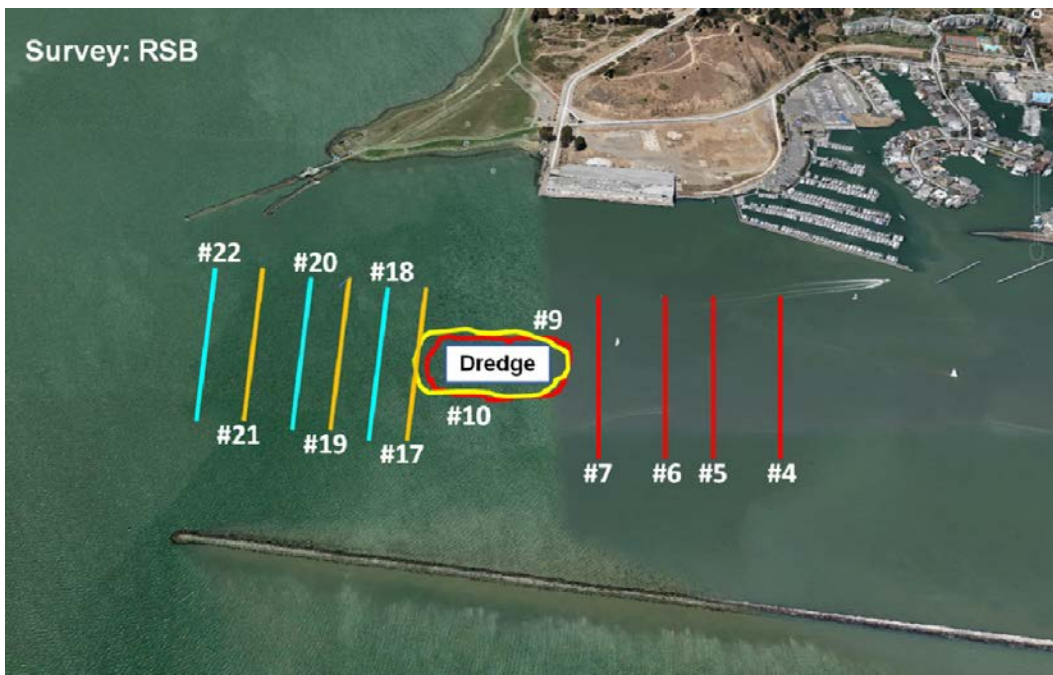
Figure 5. Layout of transects for Survey RSB.

RSB-7 (Figure 5) are representative files depicting ambient conditions. Transects extended laterally across the navigation channel in a north-south direction. Transect length ranged from 49 to 70 m (mean = 58 m).

A second during-dredging ebb tide survey (RSB) produced similar results. A plan-view layout of the survey transects is presented in Figure 5. Figures 10 through 13 (RSB 4 through RSB-7) consisted of a series of four parallel transects (Figure 5, red transect lines) occupied east of the dredge's location, opposite to the direction of current flow, to map ambient TSS concentrations (discussed in a previous section). Background TSS concentrations averaged less than 20 mg/L.

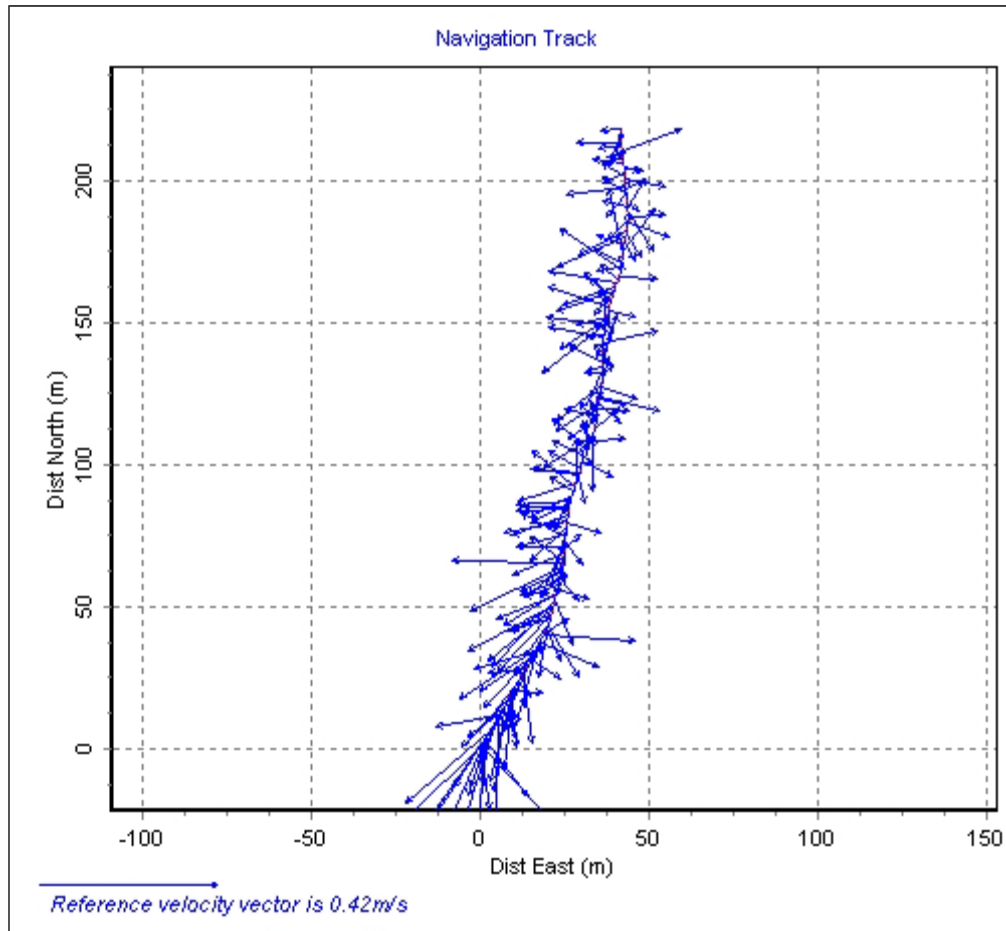
Figure 6. Vector profile showing somewhat random directional vectors due to lack of strong current flows at the study site. Net movement of water was in a west-southwesterly direction during ebb tide.

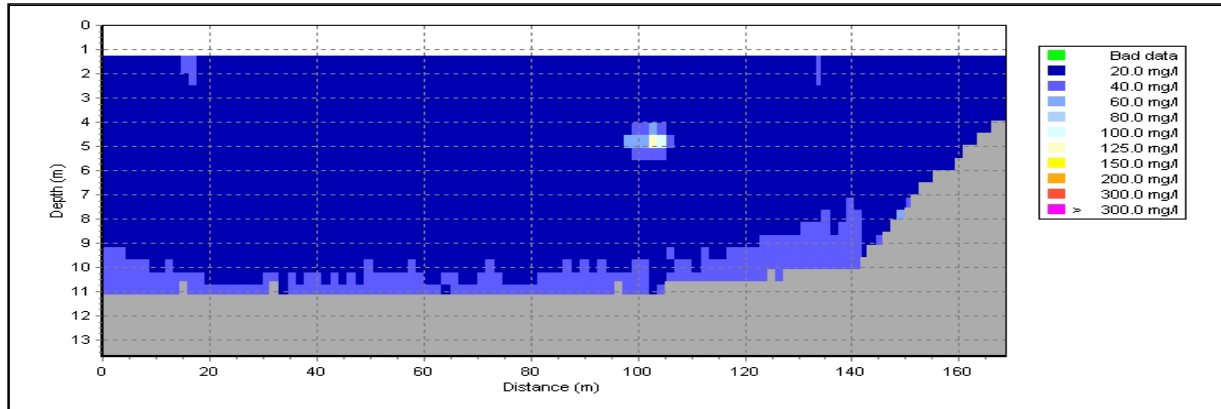
Figure 10 (RSB-4). Ambient transect occupied 233 m upstream, astern of dredge (east of dredge position). Transect heading is 165°. Some residual plume with TSS concentrations less than 40 mg/L, exceeding ambient by less than 20 mg/L occur in the lower 1 m of the water column.

Four additional ambient transects were occupied as part of a second survey. Figures 10 through 13 (Transects RSB-4 through RSB-7) consisted of a series of four parallel transects occupied east of the dredge's location, opposite to the direction of net current flow. Again, TSS concentrations remained less than 20 mg/L along all four upstream transects. As seen in the previous ambient transects, TSS concentrations along the immediate channel bottom were as high as 40 mg/L. This area of higher TSS concentrations typically occurred in the lower 1 m of the water column. Based on these two surveys, TSS concentrations equal to or below 20 mg/L will be assumed to represent ambient conditions for comparison to plumes generated by the dredging process. However, ambient TSS concentrations in the lower 1 m of the water column may be as high as 40 mg/L. A conservative value of 20 mg/L will be used for the entire water column to compare to TSS values obtained from suspended sediment plumes.

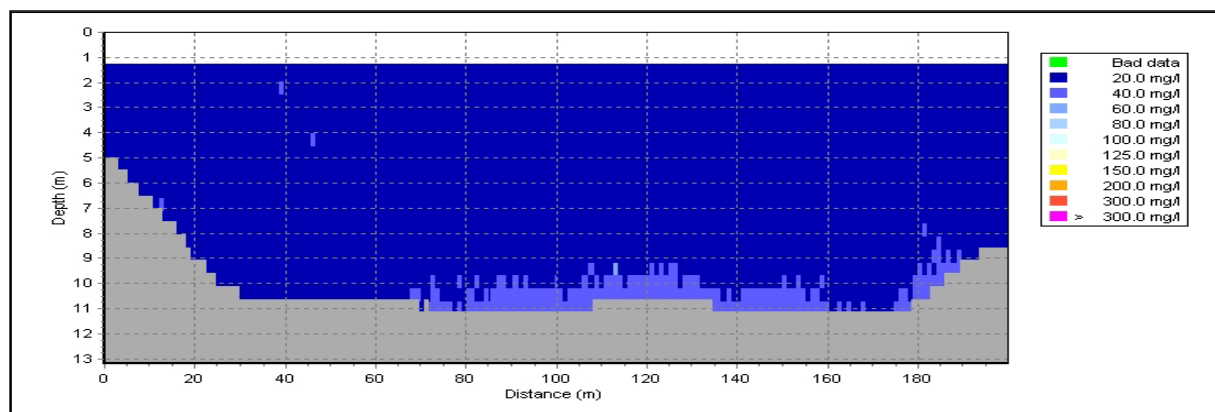
Figure 13 (RSB-7). Ambient transect occupied 76 m upstream and astern of dredge (east of the dredge position). Transect heading is 355°. Some residual plume with TSS concentrations of less than 40 mg/L, exceeding ambient by less than 20 mg/L, occur in the lower 1 m of the water column.

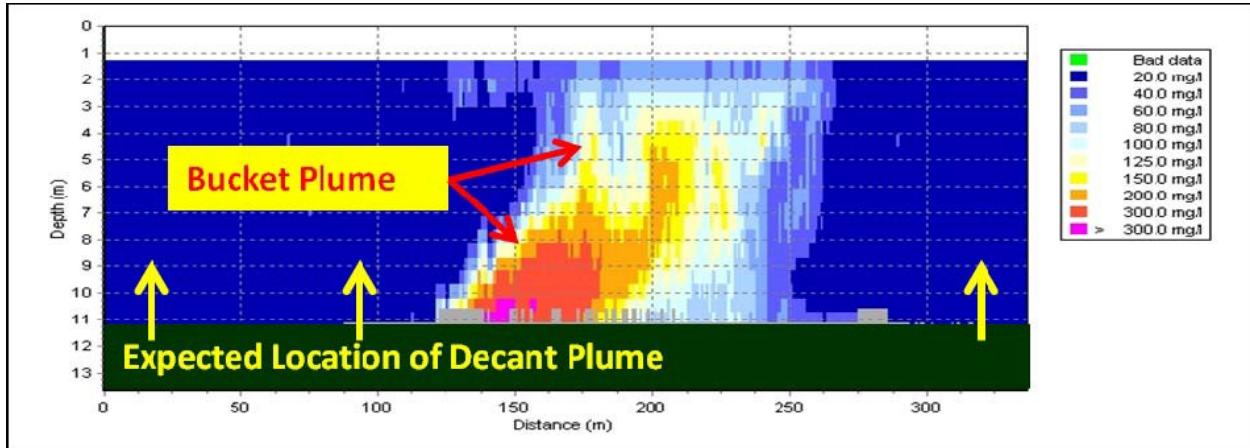
Figure 14 (RSA-8). Circle around the dredge (See Figure 4 yellow circle). Plume generated by sediment excavation, 30 m from the source. Plume movement is in a westerly direction. No evidence of decanting discharge signature in ADCP concentration profile. Yellow arrows indicate port, starboard, and astern positions relative to the dredge scow in the areas of expected decant plume location.

Examples of TSS vertical profiles taken in close proximity to the dredge scow are given in Figures 14 through 16 (RSA-8, RSB-9 and RSB-10, See Figures 4 and 5 for transect layout). These three transects encircled the dredging operation passing to within 1 m or less of the barge scow. Figure 14 (RSA-8) shows a very distinct plume generated by the bucket during sediment removal. The three yellow arrows represent directions starboard, port, and astern of the dredge scow in the areas where the decant plume would be expected. No evidence of the decant plume was observed on the ADCP vertical profile or visually on the water surface by the field crew. Figure 15 (RSB-9) depicts a small plume of very low TSS concentrations (< 40 mg/L) confined to the lower 2 m of the water column. It is uncertain whether this small area of higher TSS concentrations is associated with the decanting process or residual plume. When factoring in ambient TSS levels, this small plume would exceed background levels by no more than 20 mg/L. Figure 16 (RSB-10), repeated Transect RSB-9 approximately 1 hr later. The ADCP did not detect any evidence of increased TSS due to decanting.

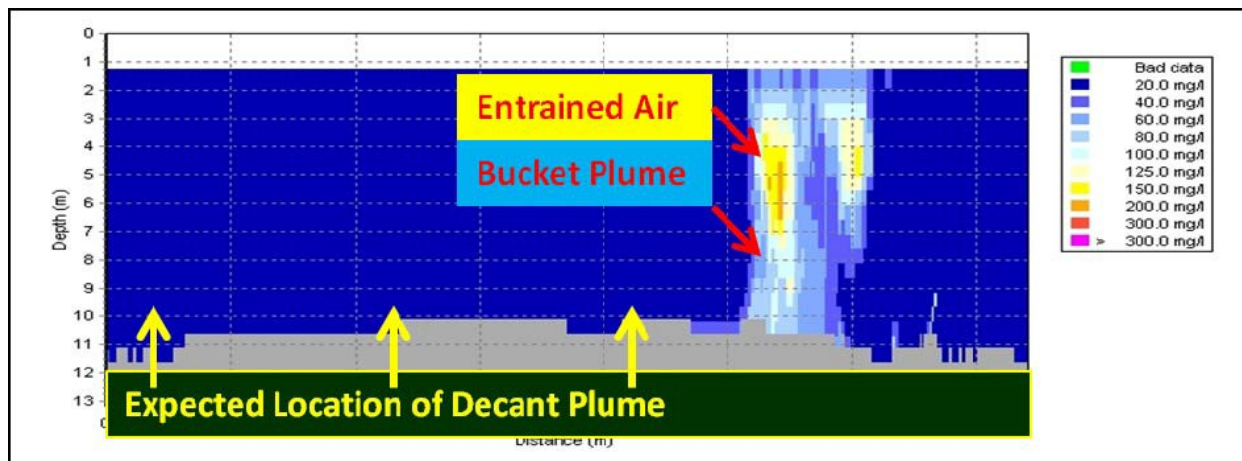
Figure 16 (RSB-10). Transect encircled the dredging operation (Figure 5, yellow circle). The plume is associated with the sediment excavation process and not decanting. Transect occupied 40 m from the bucket. Note: entrained air is suspected in the plume signature at this distance. This transect repeats the above transect (Figure RSB-15) 1 hour later.

Figure 16 (RSB-10) also encircled the dredging operation (Figure 5, yellow transect line), passing within 40 m of the insertion point of the dredge bucket (again, not the distance to the area of the expected decant plume). Again a well-defined plume signature is evident against ambient conditions located both to the north and south of the plume signature. Unlike the previous transect (RSB-9, Figure 15), which encircled the dredge where a small plume, possibly generated by decanting, was detected in the lower portion of the water column; no plume was detected outside of that generated by the bucket during sediment excavation. This transect casts

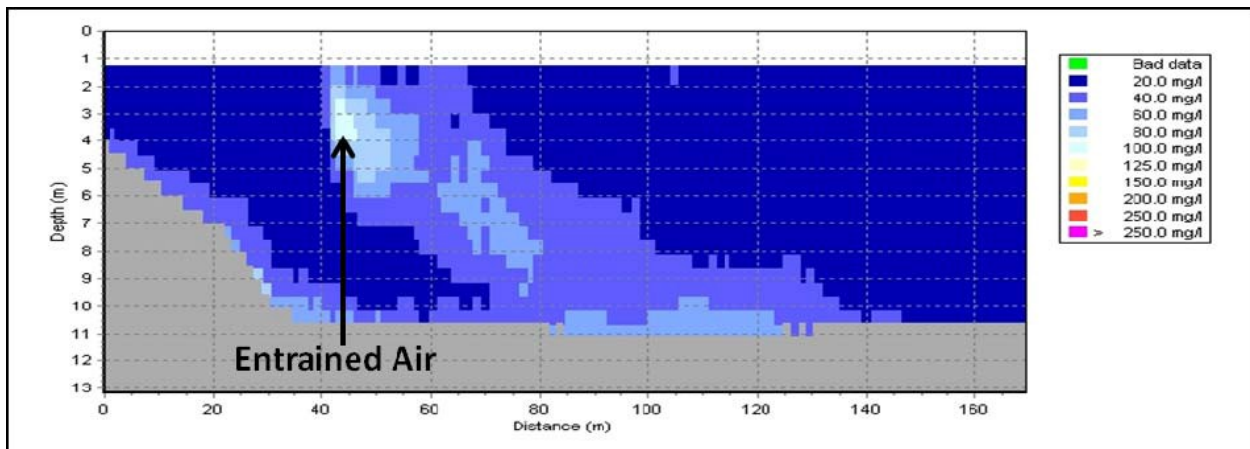
Figure 18 (RSA-12). Transect occupied 110 m from the dredge. Dredge removing sediment with overflow. Plume depicted is from sediment excavation. Decanting plume not detected. Plume movement is in a westerly direction.

Figure 18 (RSA-12) shows a rapidly decaying plume located only 110 m from the source. Entrained air is still present in the upper 2 to 5 m of the water column. The majority of the plume’s volume has TSS concentrations of less than 40 mg/L, exceeding ambient by 20 mg/L. An area along the channel side slope has slightly elevated TSS concentrations, consistent with ambient conditions observed earlier.

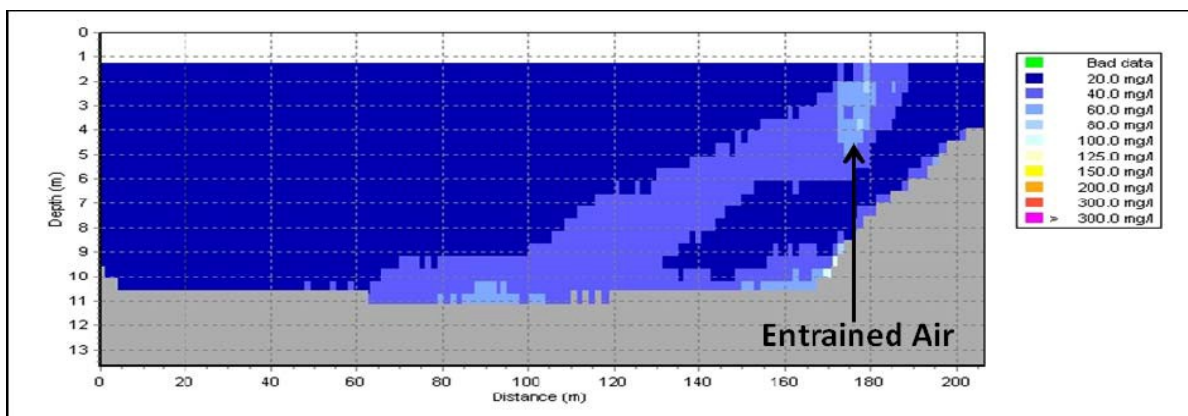
Figure 19 (RSA-13). Transect occupied 132 m from dredge. Dredge is shutdown but still overflowing. Plume depicted is from sediment excavation. No evidence of decanting plume. Dredge stopped digging after the completion of this transect. Total time removing sediment was 22 min.

Figure 19 (RSA-13) is the final transect in which the plume signature extended from surface to bottom. This transect was occupied only 132 m from the dredging operation. A small area of entrained air is visible on the far right side of the ADCP vertical profile between depths 2 and 5 meters. TSS concentrations exceeded ambient by less than 20 mg/L throughout the water column. The dredge stopped removing sediment at the completion of this transect, although the supernatant was still discharging from the scow. The total elapsed time the dredge was removing sediment was 22 min.

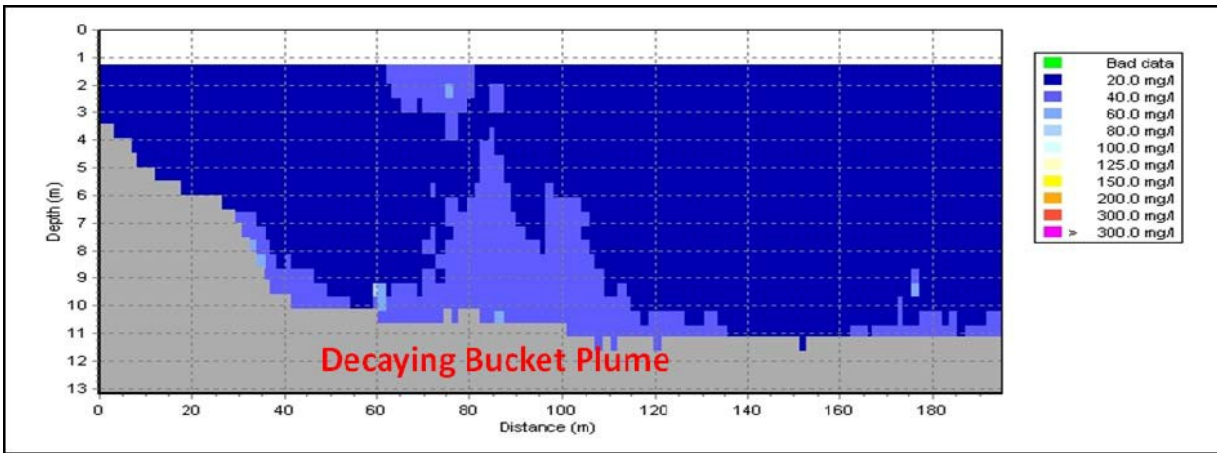
Figure 24 (RSB-18). Transect occupied 95 m from the dredge shows the rapid decay of the plume from 50 m to 95 m from the source. Some air is entrained in the upper 3 m of the water column. No decanting plume was detected. TSS concentrations exceeded ambient by < 20 mg/L.

Figure 24 (RSB 18) shows significant decay of the plume generated by the bucket over a span of 45 m (total distance from the dredging operation is 95 m). Given the slow current velocities present at the study site, some of the entrained air would have dissipated. Slow flow velocities also contribute greatly to the settling process of the resuspended sediment, inducing rapid decay of the plume. At this distance, the plume still occupied the majority of the water column, although the somewhat detached plume occupying the upper 3 m of the water column is most likely entrained air. TSS concentrations throughout the plume structure are less than 40 mg/L, exceeding ambient by less than 20 mg/L. There was no evidence of a plume generated by the decanting process.

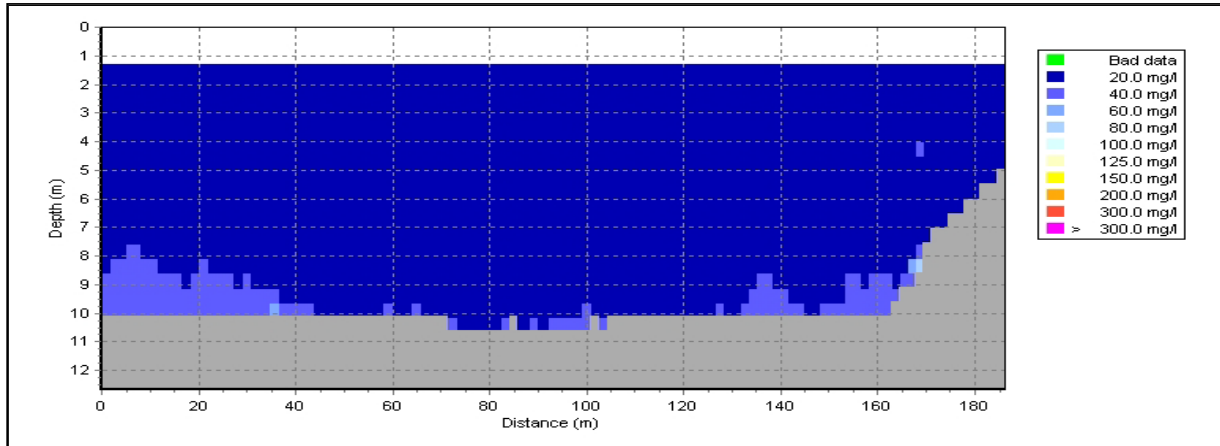
Figure 27. (RSB-21). Transect occupied 230 m downstream from the dredging operation. Transect runs in a southerly direction at 160°.

Figures 25 through 27 (RSB 19 through RSB-21) occupied at distances from 141 m to 230 m show a diffuse plume along the channel bottom occupying the lower 1 to 2 m of the water column. The final transect in the survey (Figure 28, Transect RSB-22) at a distance of 296 m from the dredging operation shows no evidence of elevated TSS concentrations associated with the dredge plume. All TSS concentrations estimated from the ADCP vertical profile fall within background levels. Currents again were too weak to carry the plume substantial distances.

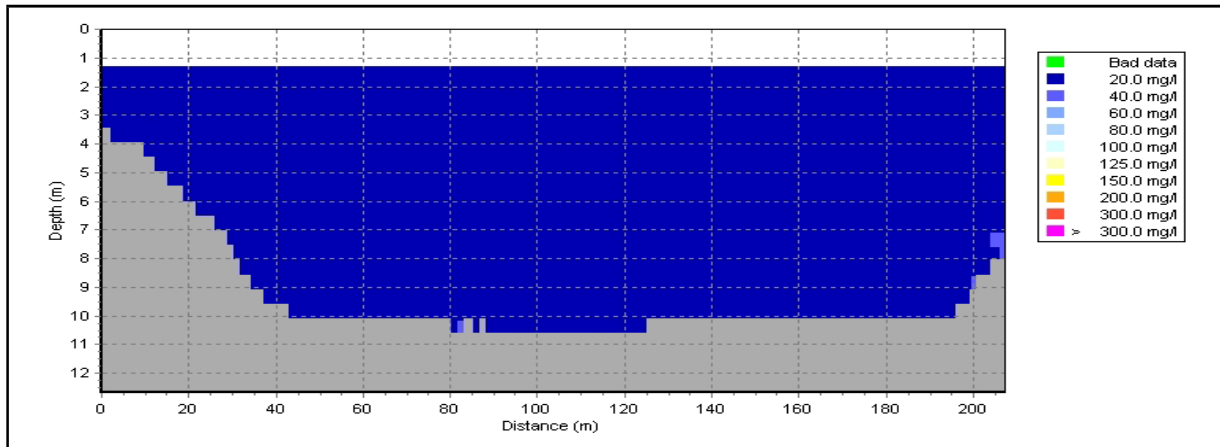
Figure 28 (RSB-22). Transect occupied 296 m downstream from the dredging operation. No evidence of the dredge or a decanting plume detected at this distance from the source. Transect runs in a northerly direction at 160°.
