Ala Wai Watershed Restoration

*ALA WAI WATERSHED RESTORATION
OCEANIT
Dayananda Vithanage P.E. PhD*

PROJECT AREA

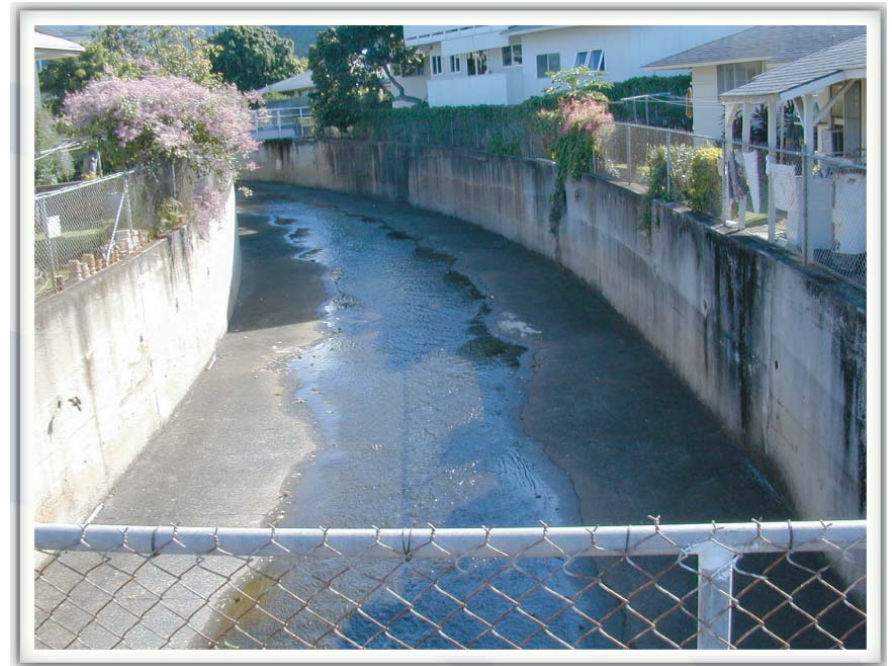
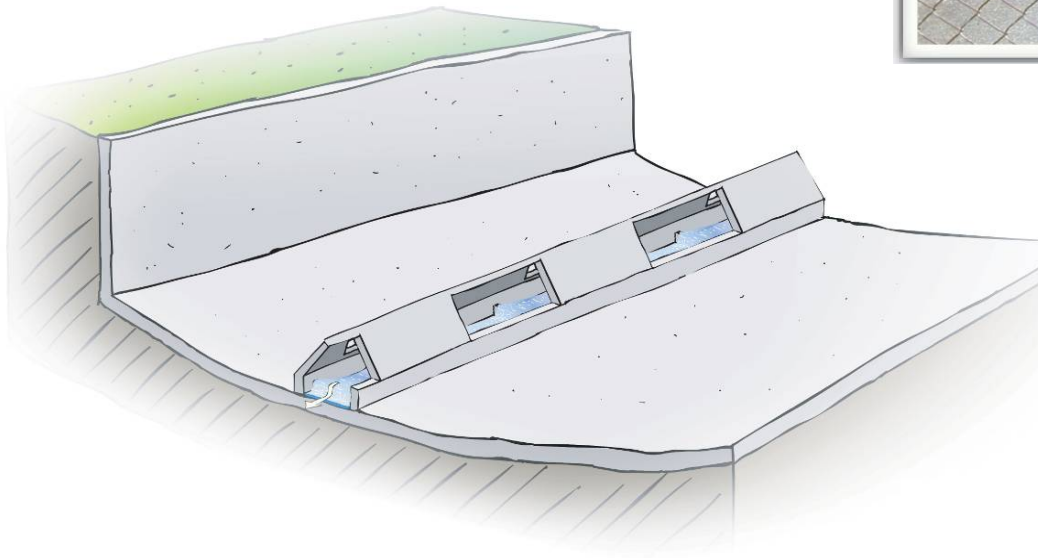
Reach 14

Upper Palolo Channel

VERTICAL CONCRETE PANELS
FOR HABITAT

LOW FLOW CHANNEL

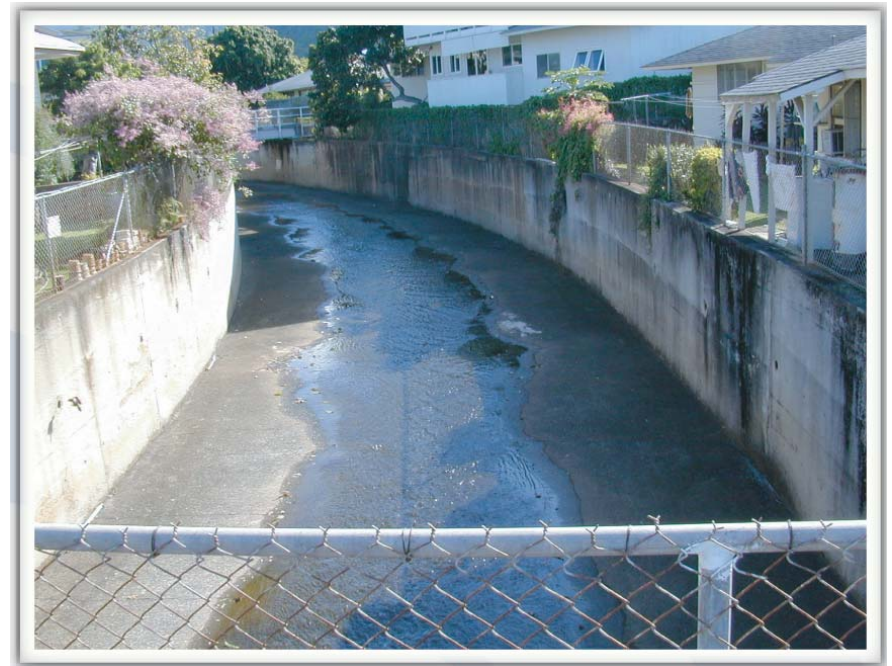
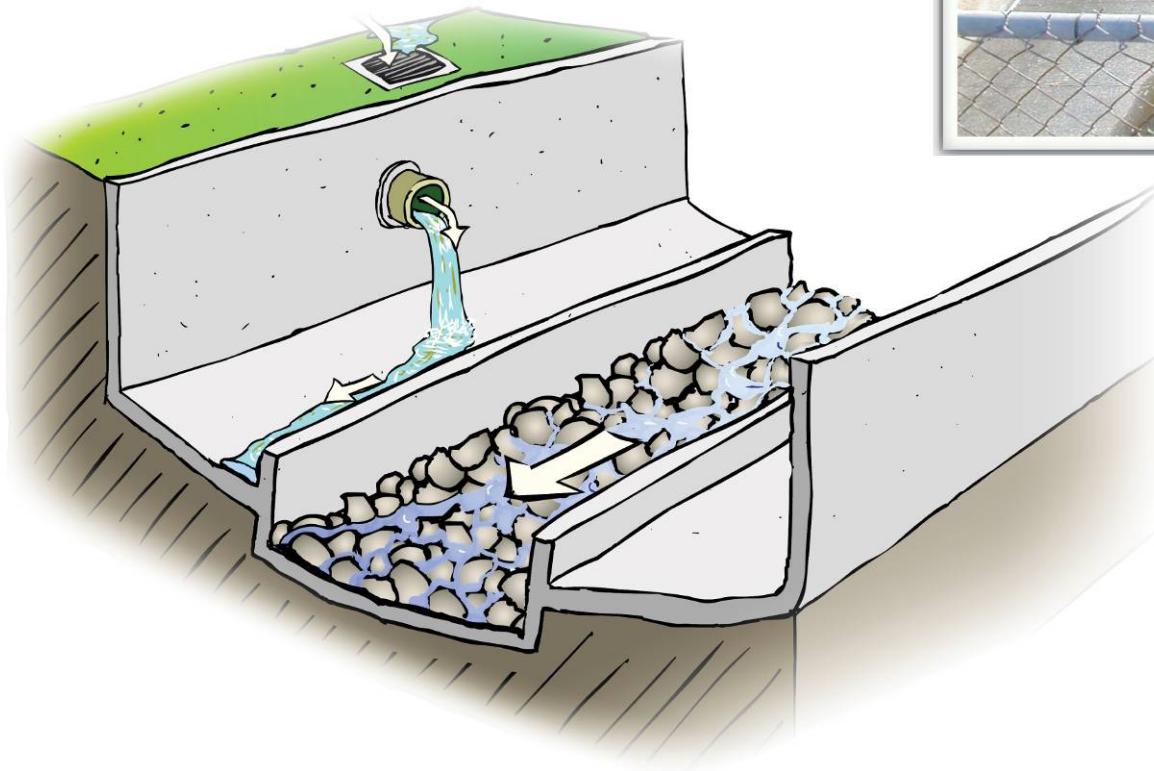
Reach 14

Upper Palolo Channel

ALUMINUM IN-STREAM
WATERWAY

FISH LADDER

ARTIFICIAL IN-STREAM
HABITAT

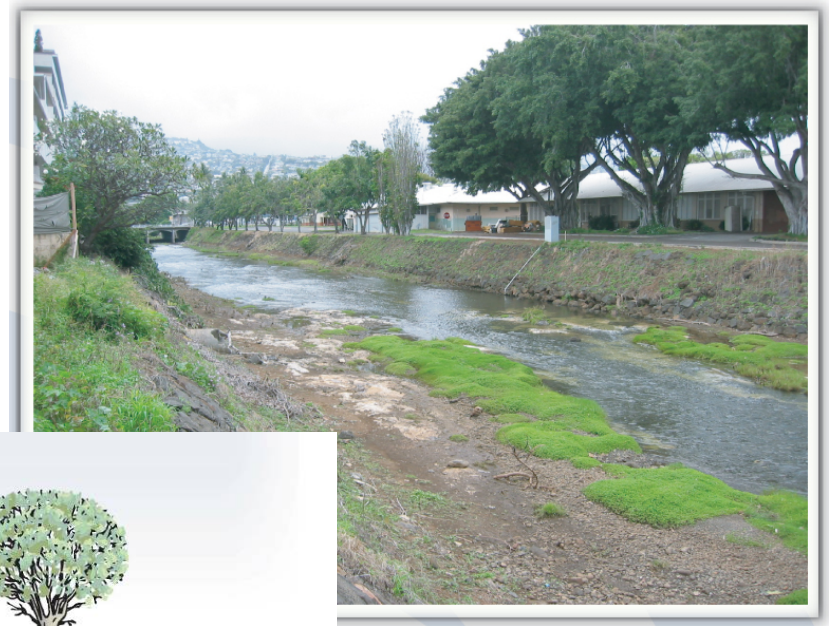
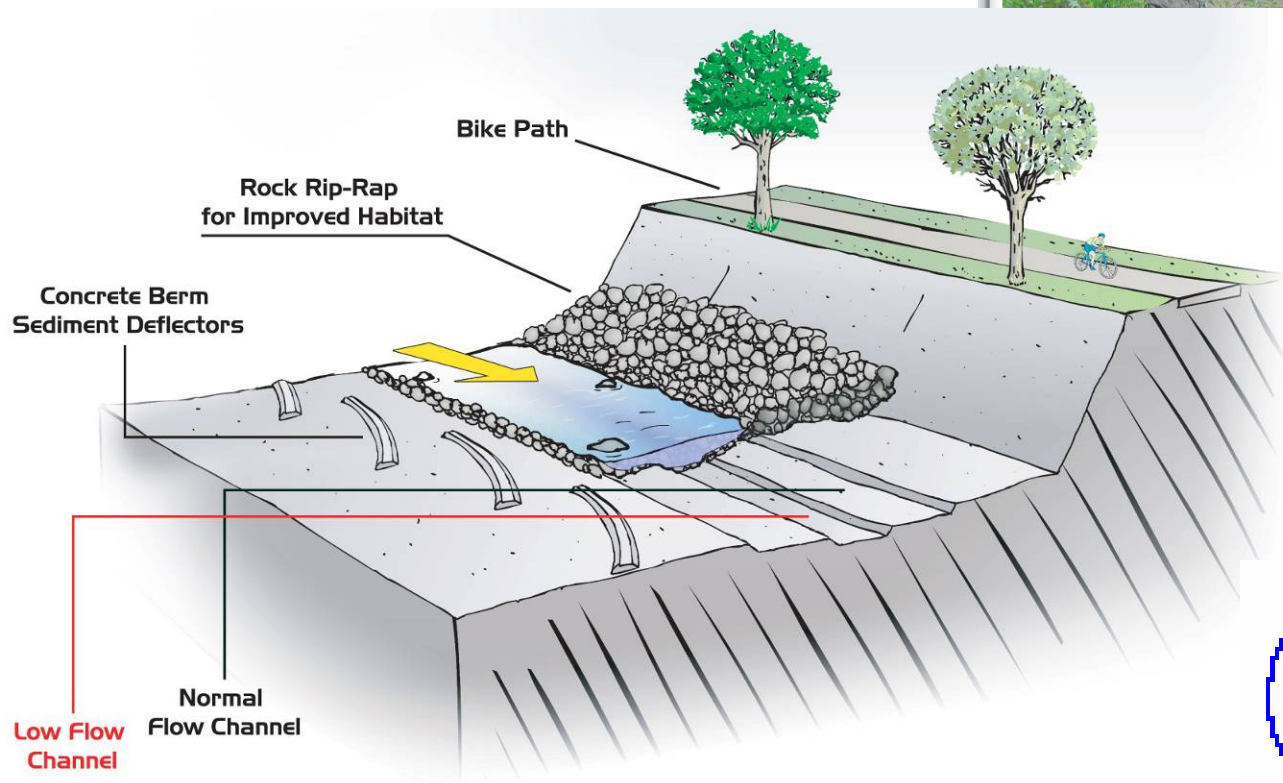
Reach 3

Manoa Palolo Channel

BIKE/ALUMINUM PATH

ALUMINUM IN-STREAM
HABITAT

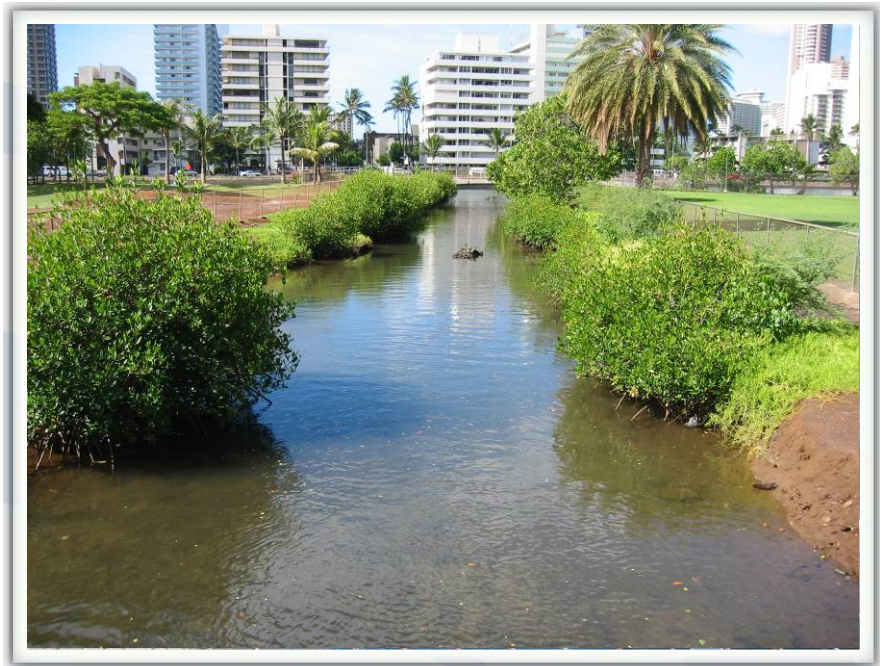
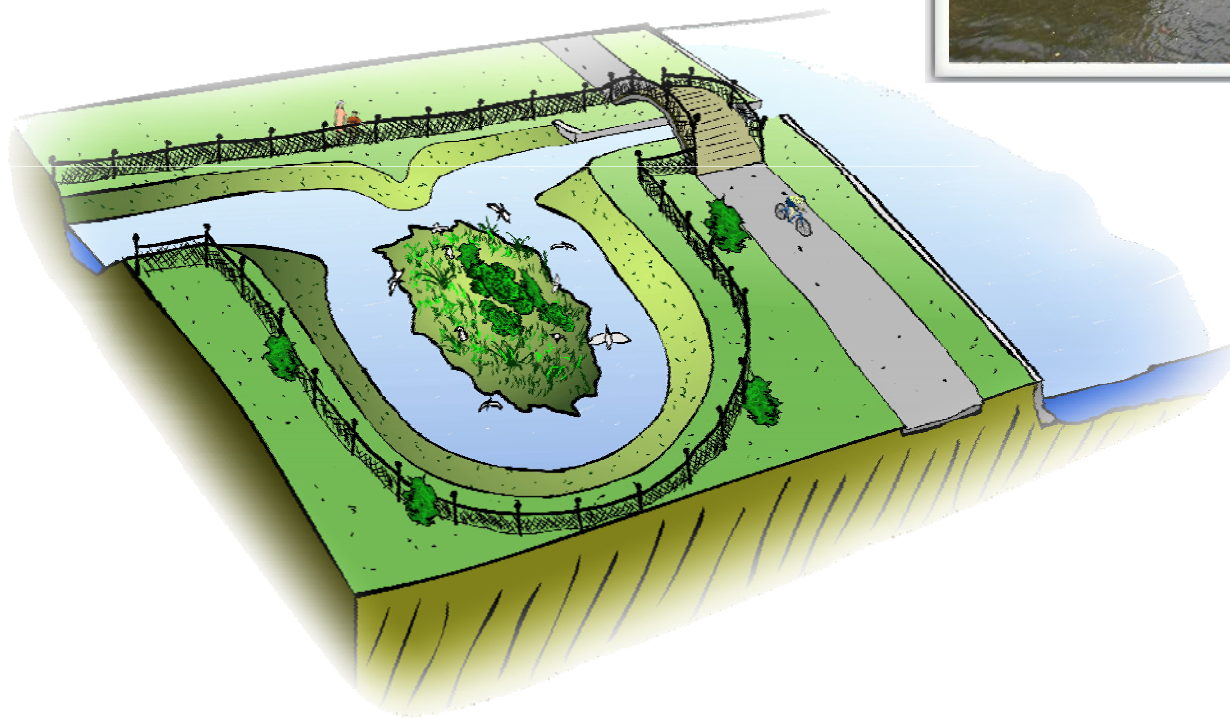
Hausten Ditch

RESTRICTED MANICURING/
HIGH-MAINTENANCE

WETLAND

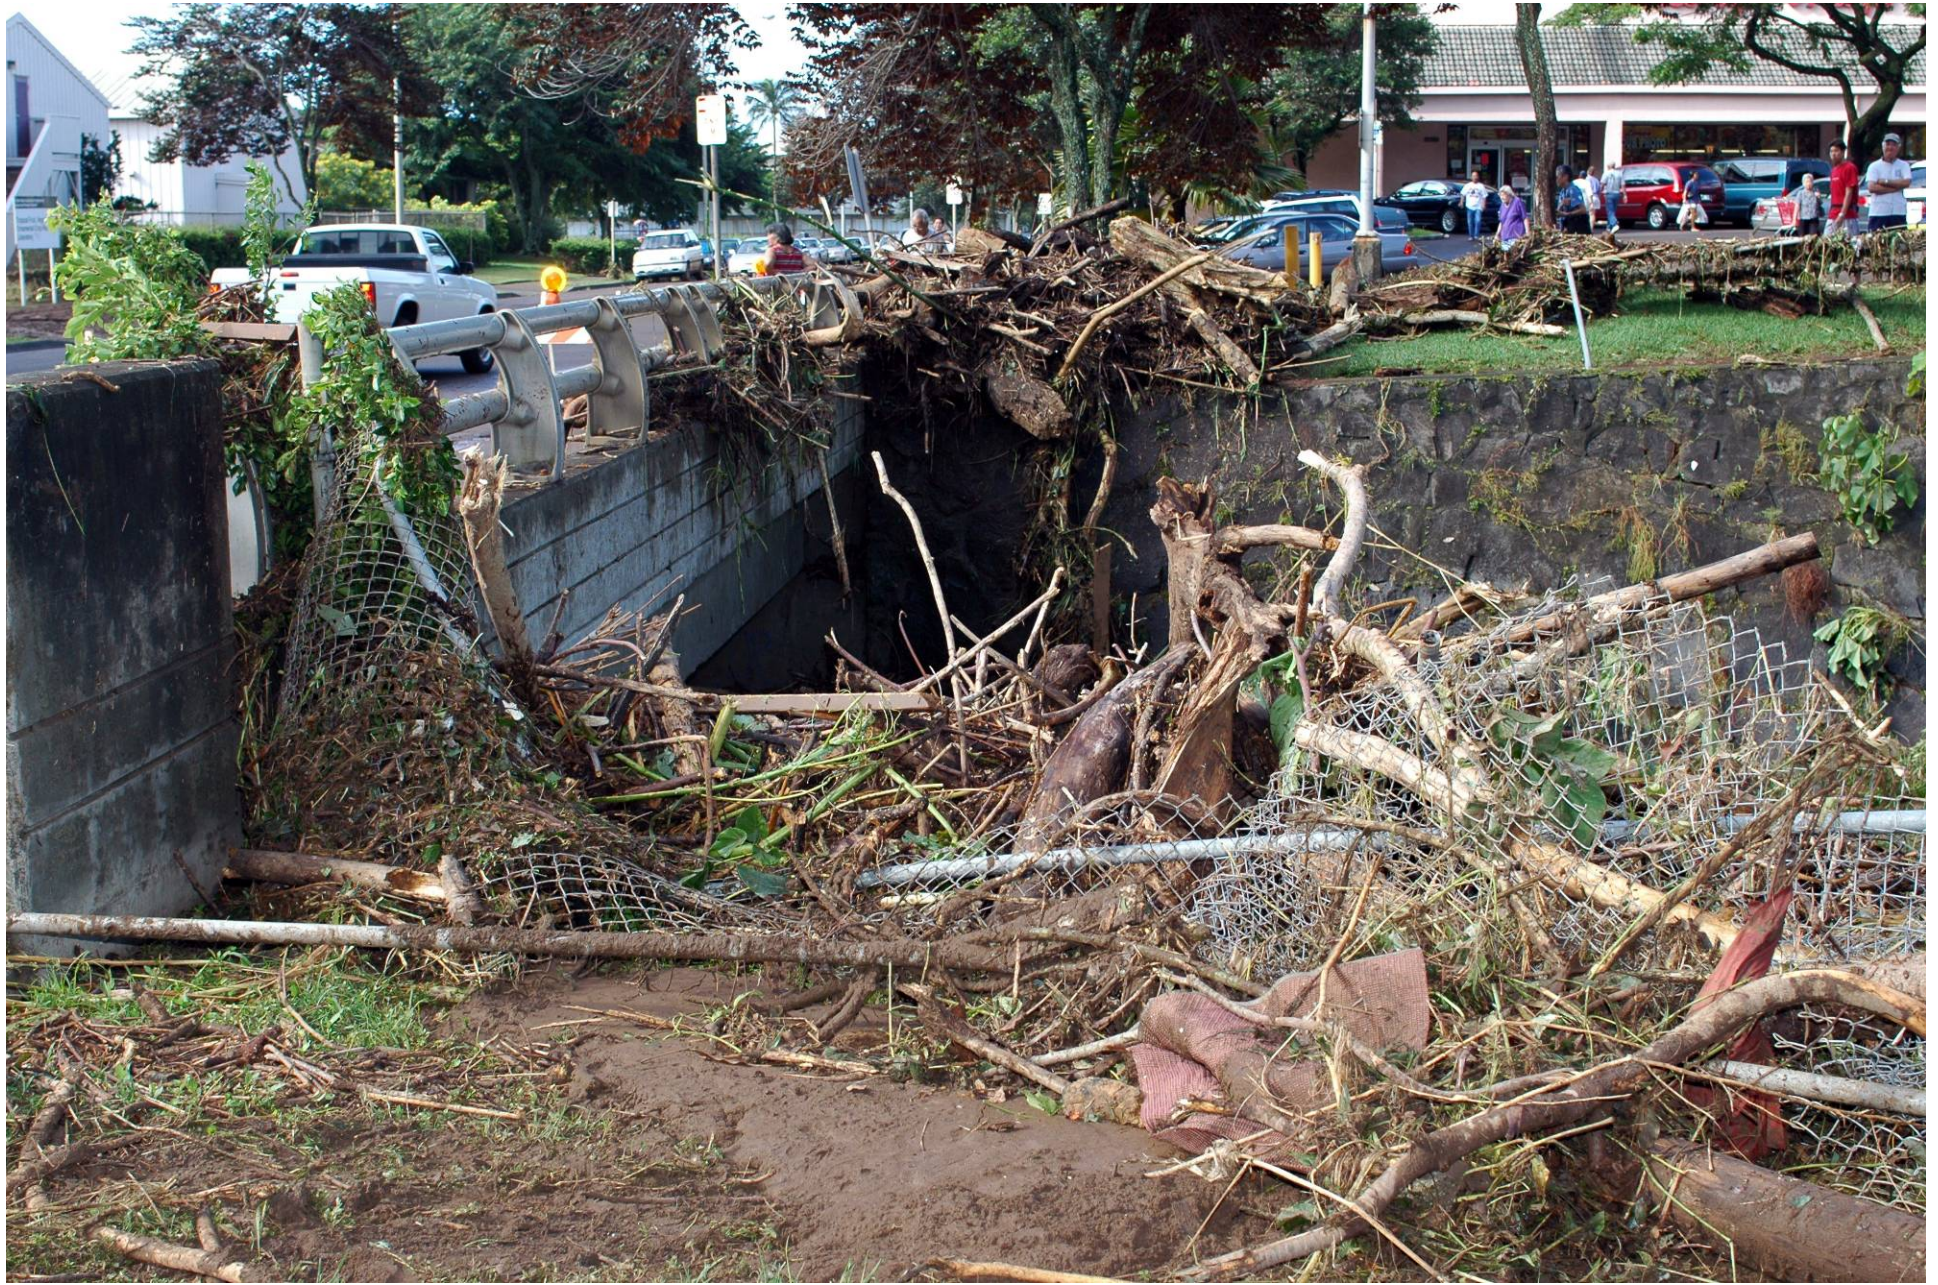
Tree Brought Down by Scour

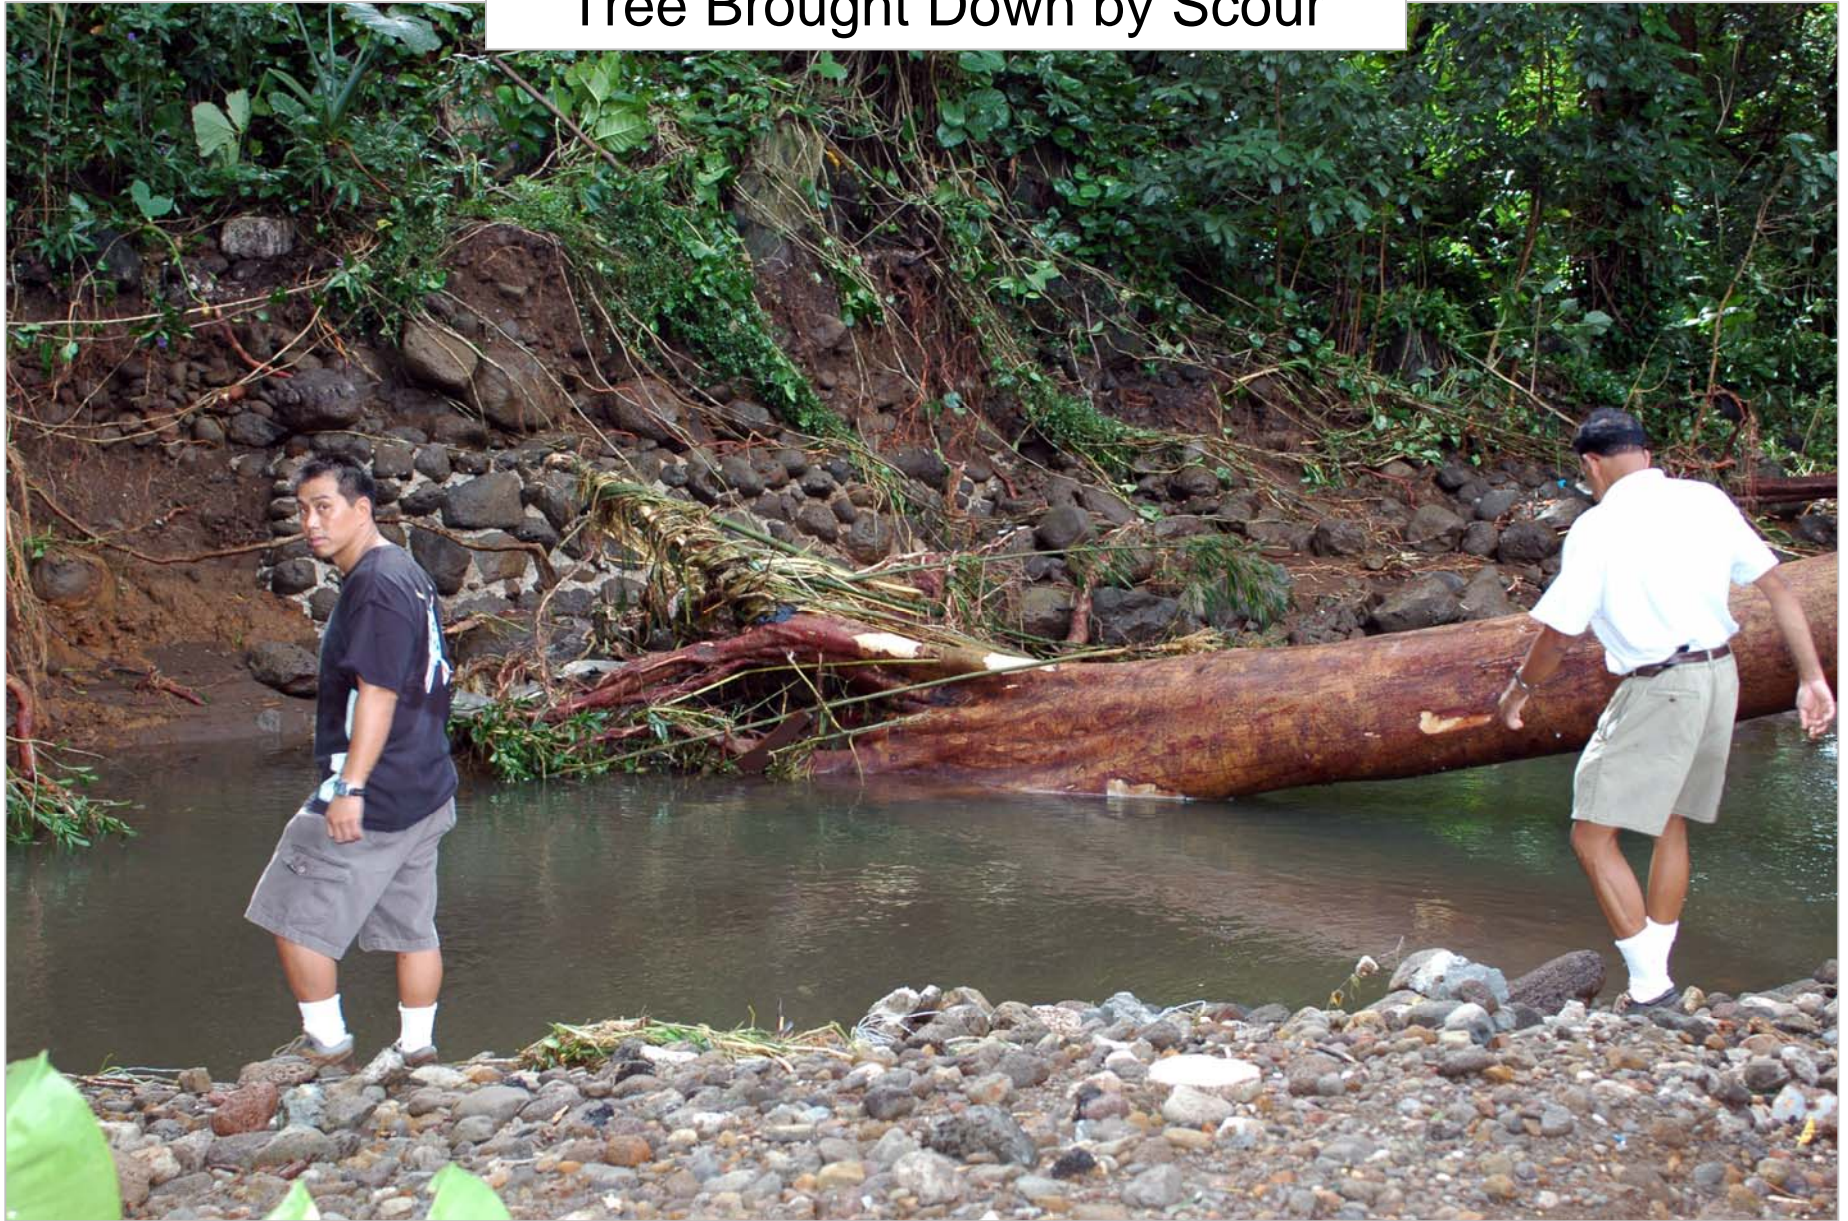
Tree Brought with Stream Flow

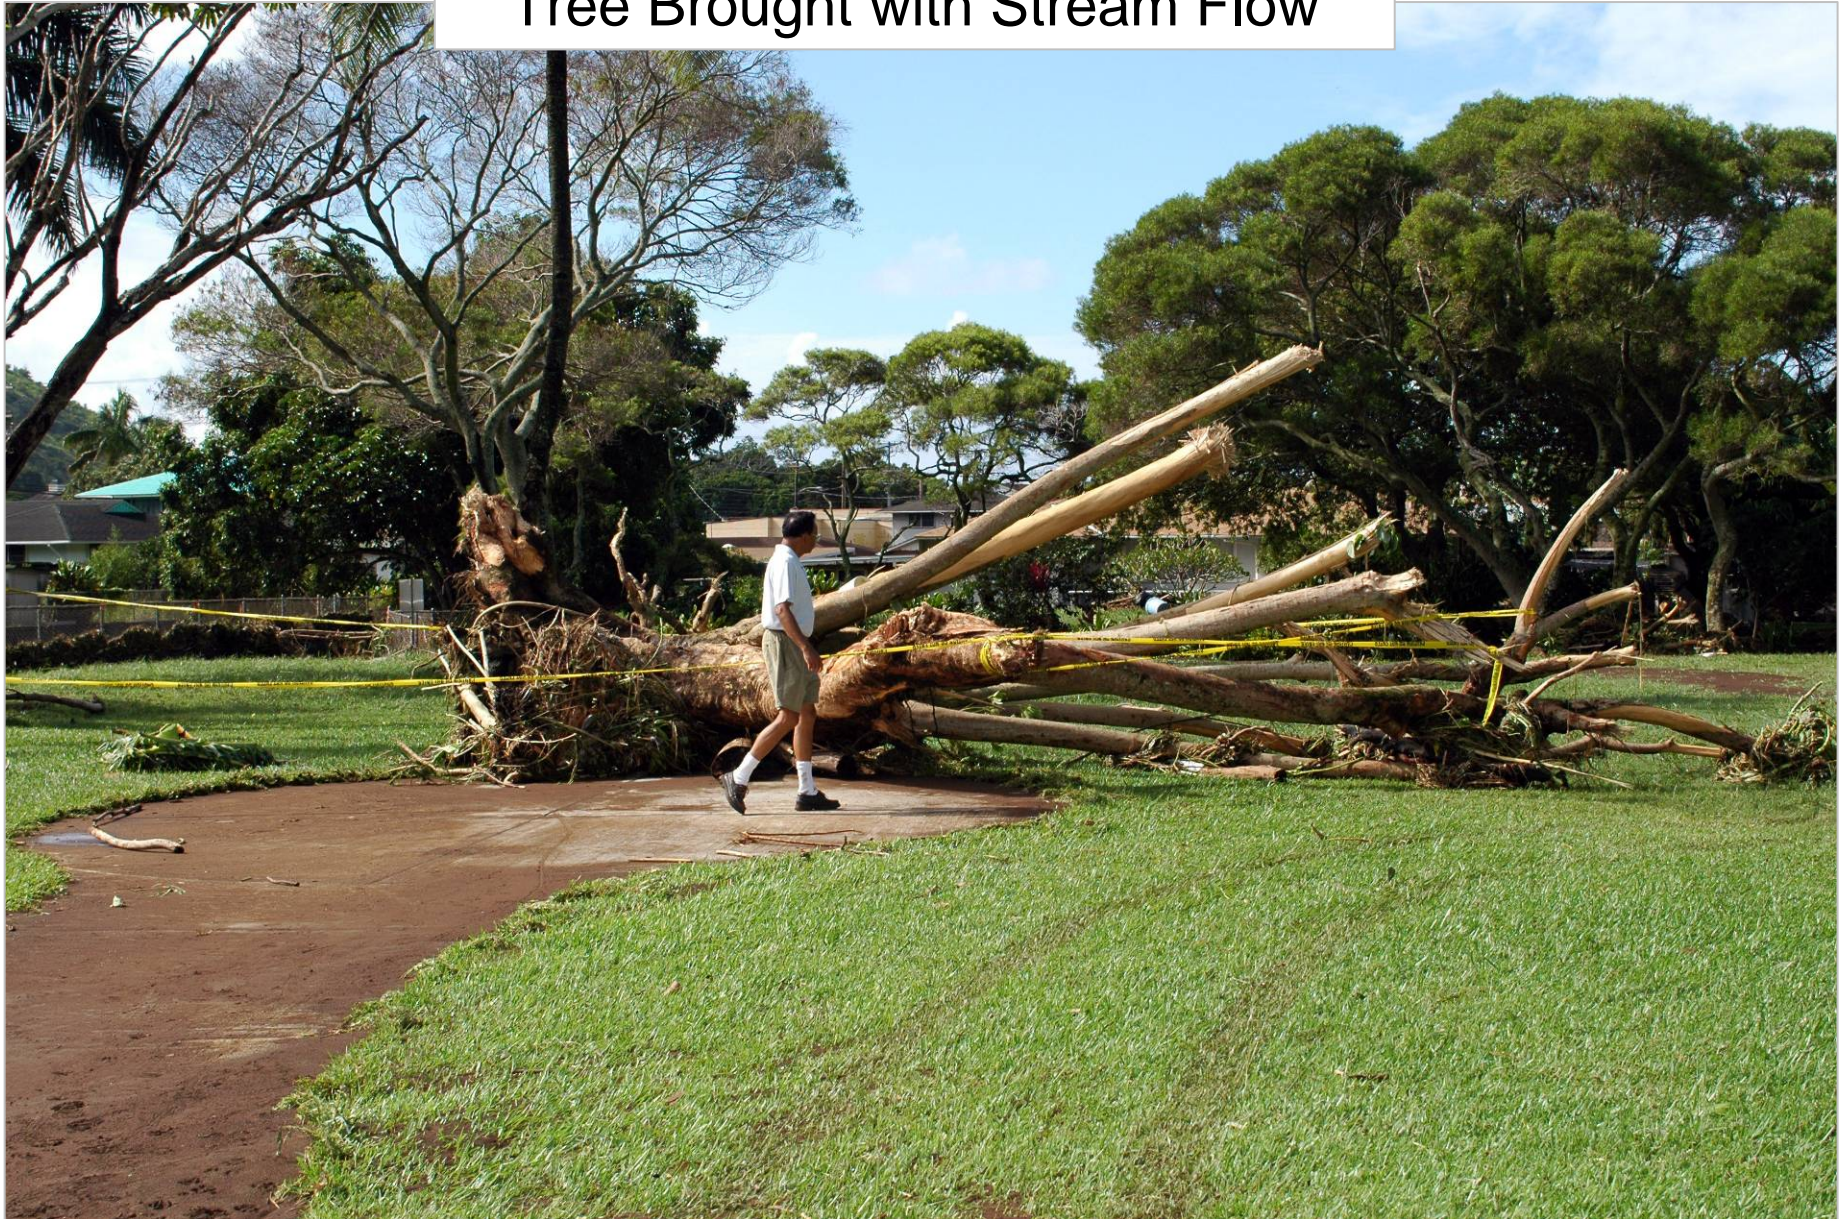
Foot Bridge Destroyed by Flood

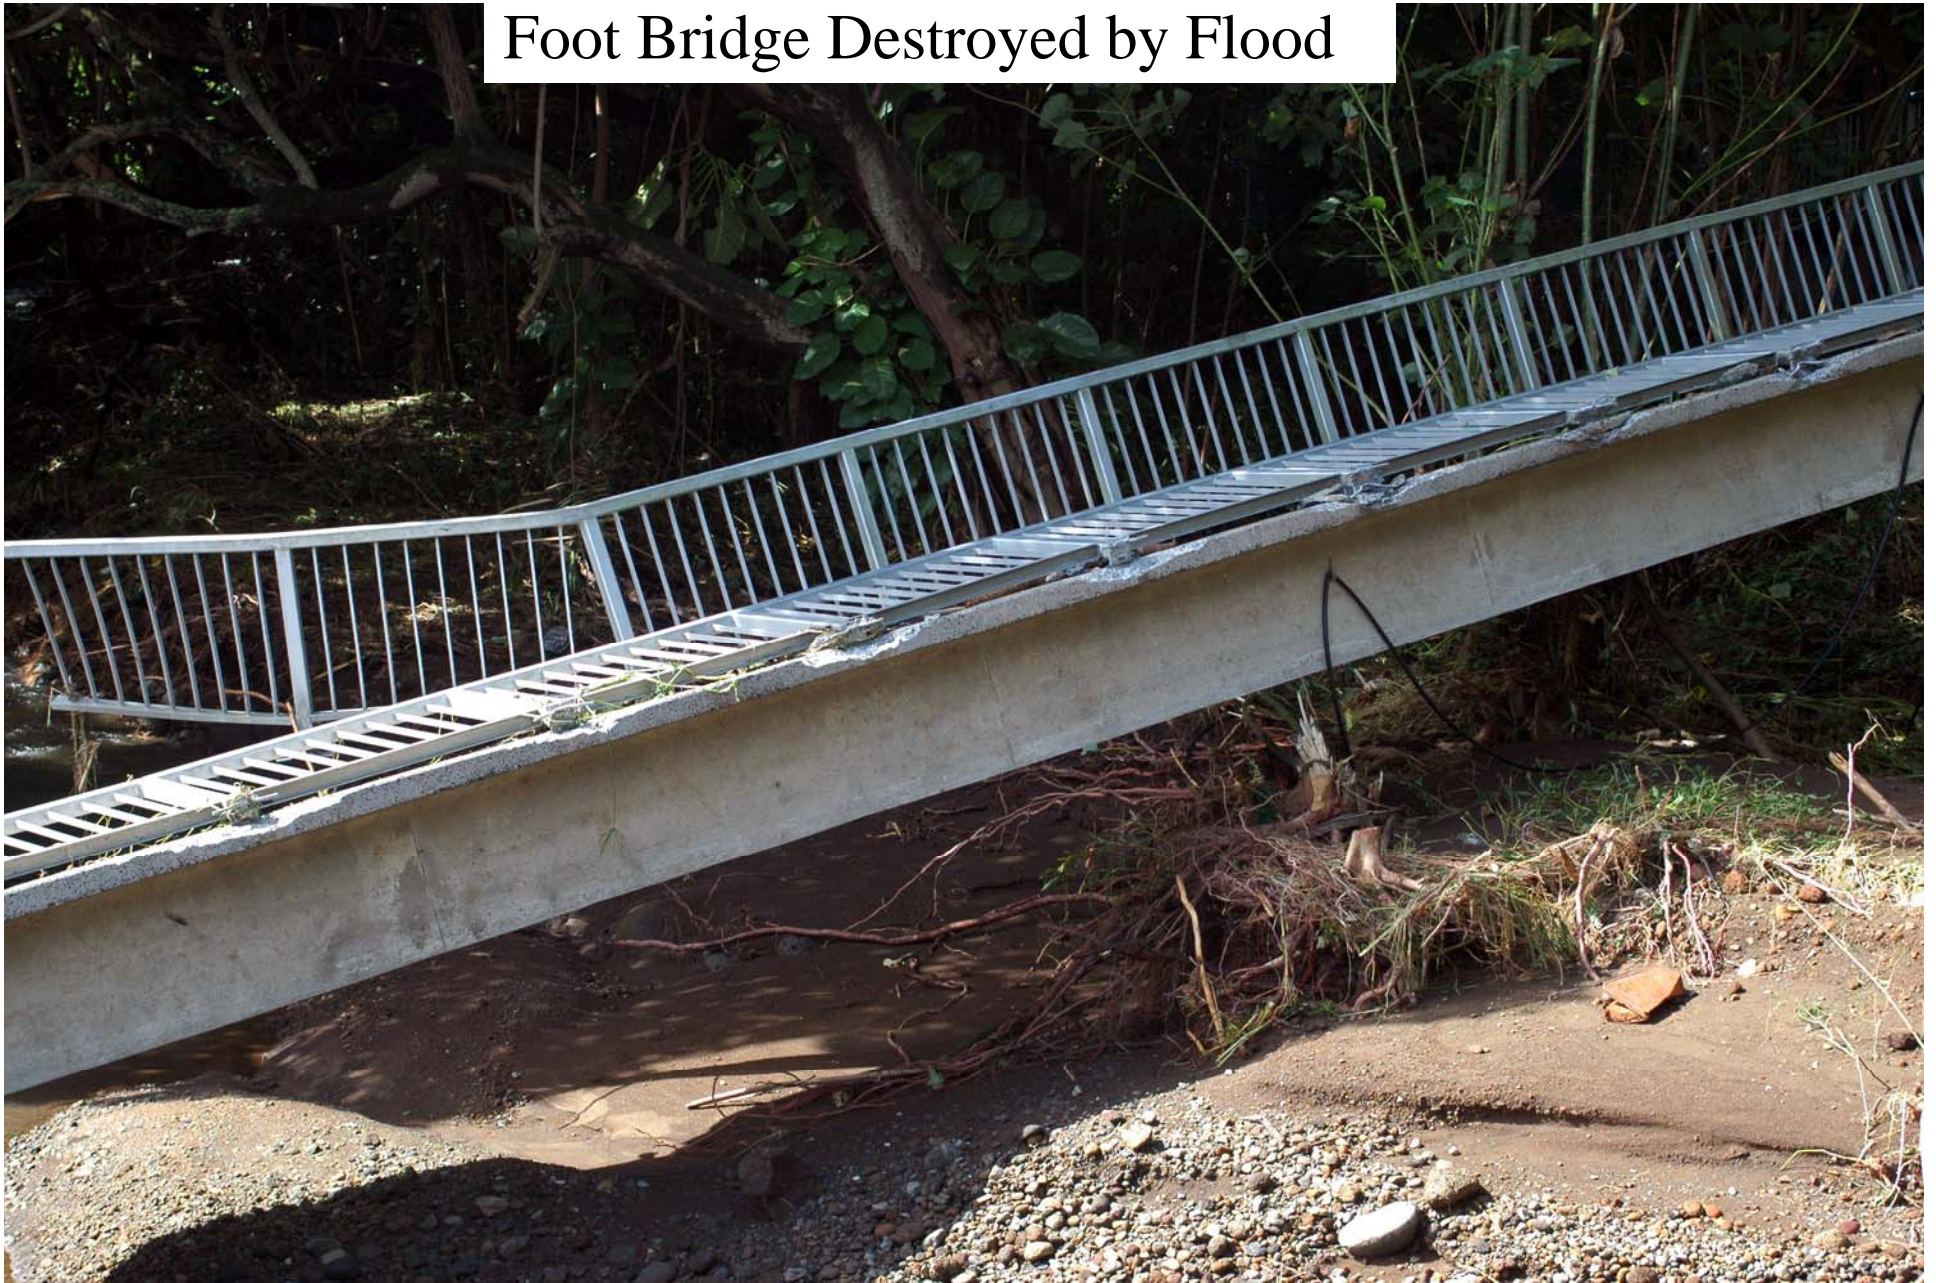
Erosion of Back of Wall by Overtopping Water

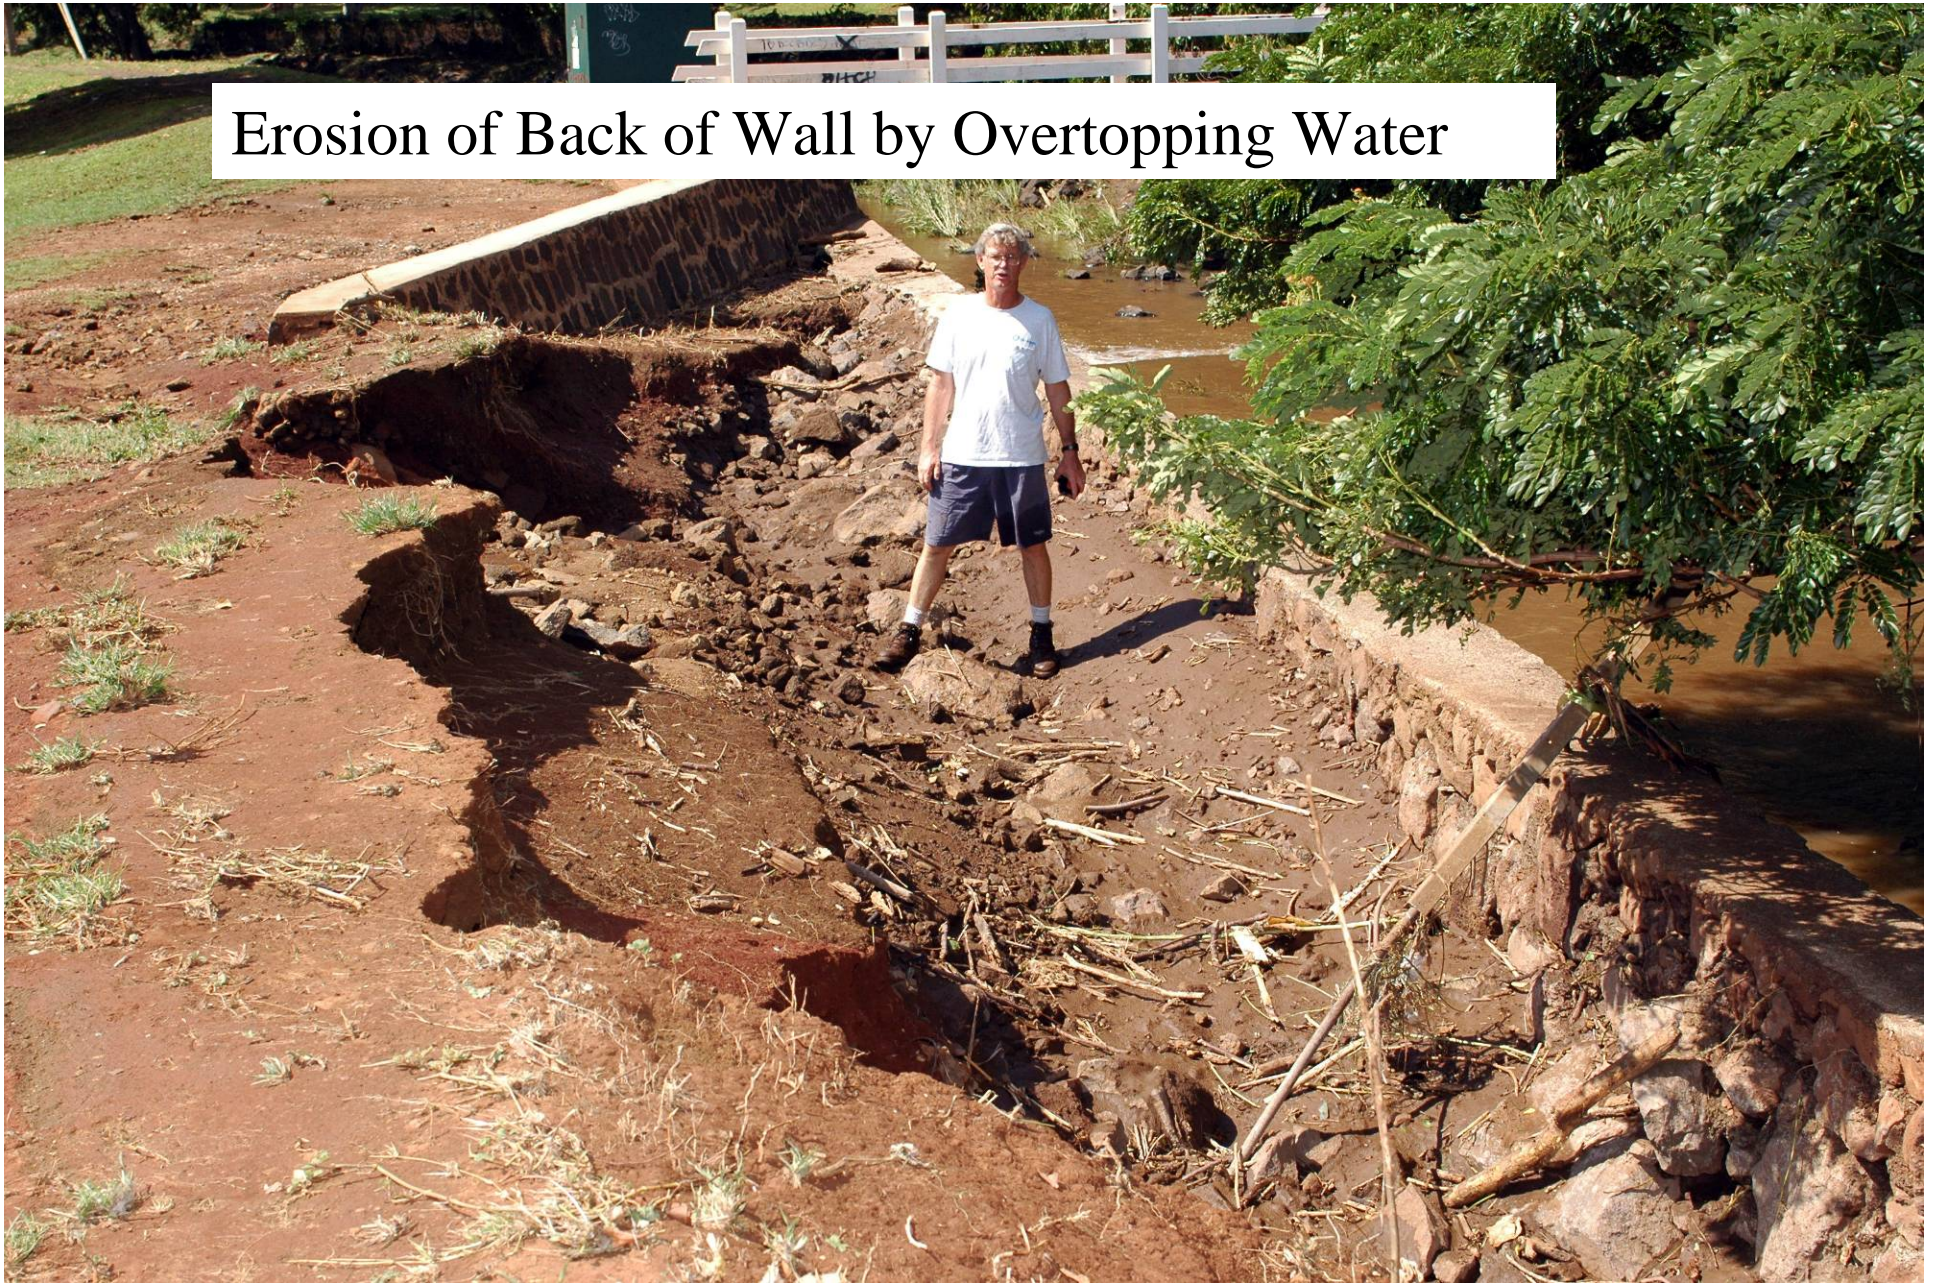
Trash Collected in Ala Wai Boat Harbor
