Response Summary:

On November 7 and November 8, 2022, Spencer Harper (CESPN-ECE-W), Jeffrey Melby (CEERD-HNH), Dylan Robinson (CEERD-HNC) and Chad Bounds (CEERD-HNH) provided a walkover inspection of the north jetty at Noyo Harbor, CA in response to a DOTS request. SPN requested a site visit from the ERDC team to understand the conditions of Noyo Harbor, and the failing north jetty. A previous inspection of Noyo Harbor's jetties, conducted by SPN on August 11, 2021, described a large depression in the jetty crest on the leeward (north) side of the concrete monolith approximately 10 feet deep at some locations. The report also noted minor ejection of armor stone along the channel side of the jetty. Additionally, local stakeholders have observed large stone armoring displaced from the structure within the existing channel reducing the navigability of the channel. During the site visit, the DOTS response team observed waves breaking along the channel side of the concrete monolith creating a jet-like flow at low tide that could potentially dislodge poorly interlocked stones and move them into the channel. At high tide, the team observed waves breaking over the concrete monolith adjace

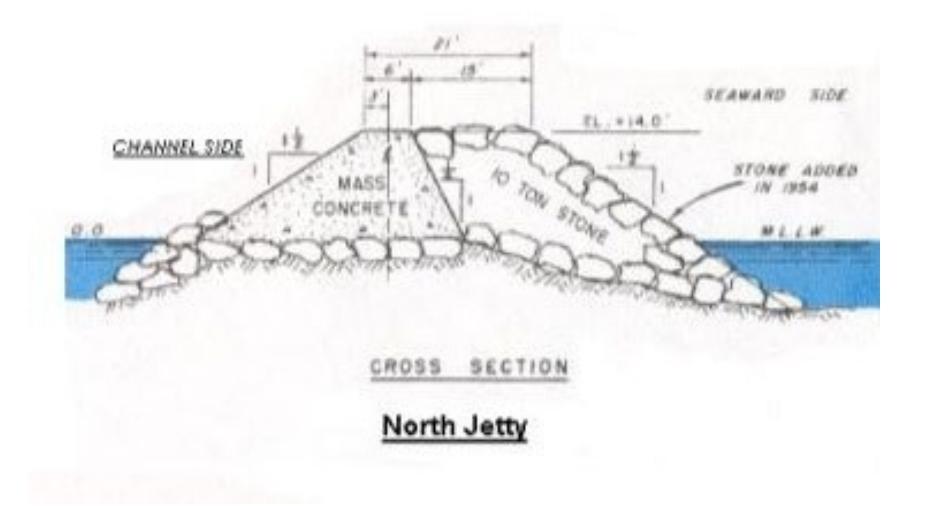
Figure 2: Noyo Harbor north jetty cross section (SPN, 2001)

Noyo Harbor's north jetty has been repaired numerous times, most recently in 2019. This repair involved placement of 10ton armor stones along the channel side of the concrete berm, while removing and reusing displaced rocks already in the channel (SPN, 2018). During this repair, a 40 to 50 foot-long cavity along the channel side of the concrete monolith at MLLW level was filled with 6-inch rock and grout.

In the 2021 jetty inspection conducted by SPN, the jetty was considered to be in fair to poor structural condition. A depression at the crest of the jetty upwards of 10 feet deep was observed, as well as poor stone size consistency along the remaining crest (SPN, 2021). Aside from a small depression where an estimated 2 to 3 stones were missing, the head of the structure remained in good condition. However, it was also observed that armor stone on the channel side of the jetty along the concrete monolith was displaced, and the base of the monolith was exposed. Stone armoring displaced from the channel side of the monolith has entered the channel and is now a navigational hazard as reported by locals. Some of this damage was attributed to a storm in January 2021, with waves reported by the local coast guard to be greater than 20 feet at the entrance to the harbor on a king tide that was near the jetty crest.
